**PHASE 1 DETAILED SHALLOW SOIL ENGINEERING GEOLOGICAL  
INVESTIGATION CONDUCTED ON ERF 1305 OF THE FARM RIETGAT 611-JR,  
SOSHANGUVE-M, GAUTENG PROVINCE, SOUTH AFRICA**

Client: **Govhani Student Accommodation**

Project number: **RS17001**

**5 April 2017**

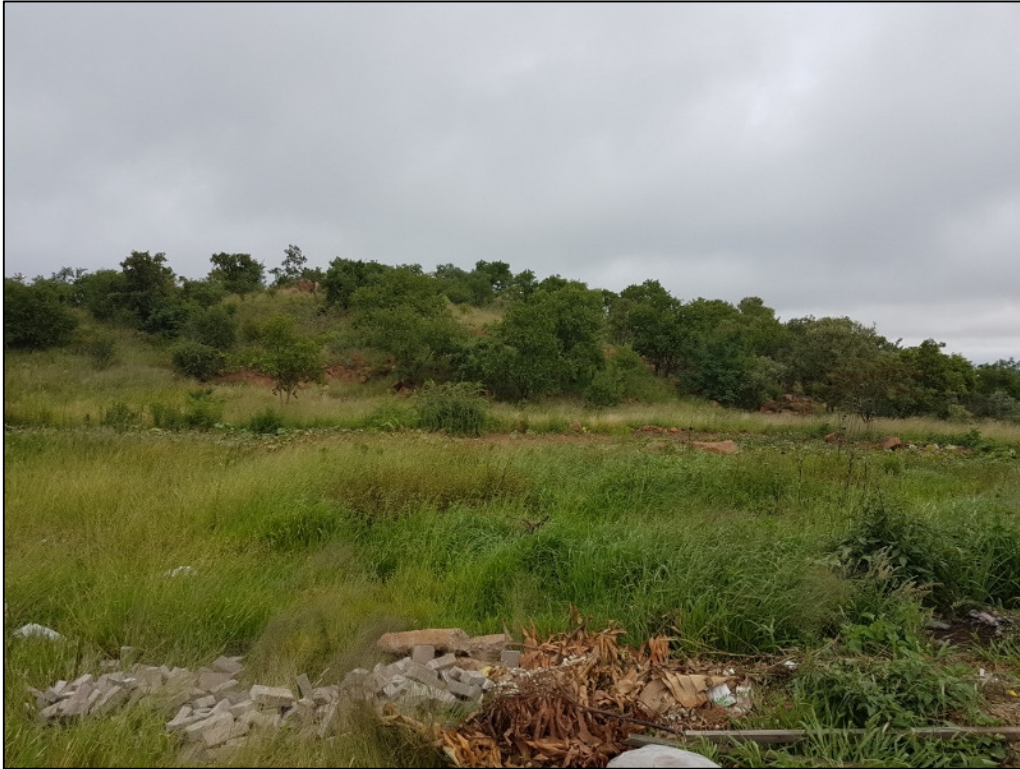
**Photograph 1:** Granophyre ridge in the background (*Photograph taken from test pit TP02 in a SE direction*)

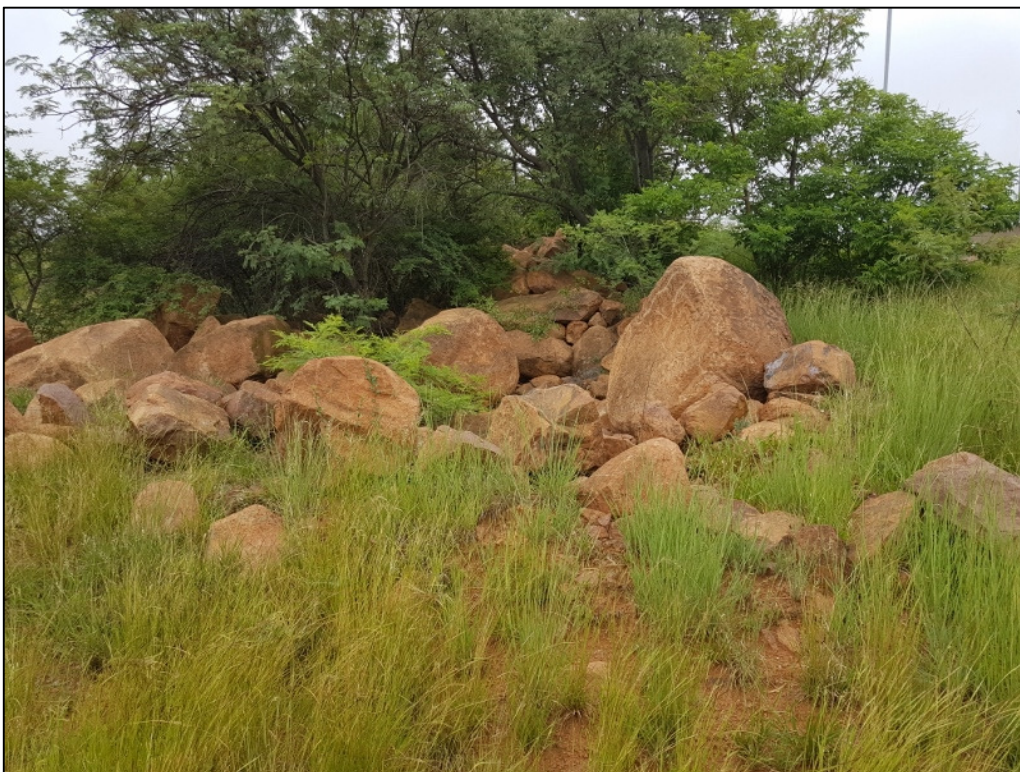
**Photograph 2:** Abundant large granophyre boulders (*Photograph taken from test pit TP20 in a NE direction*)

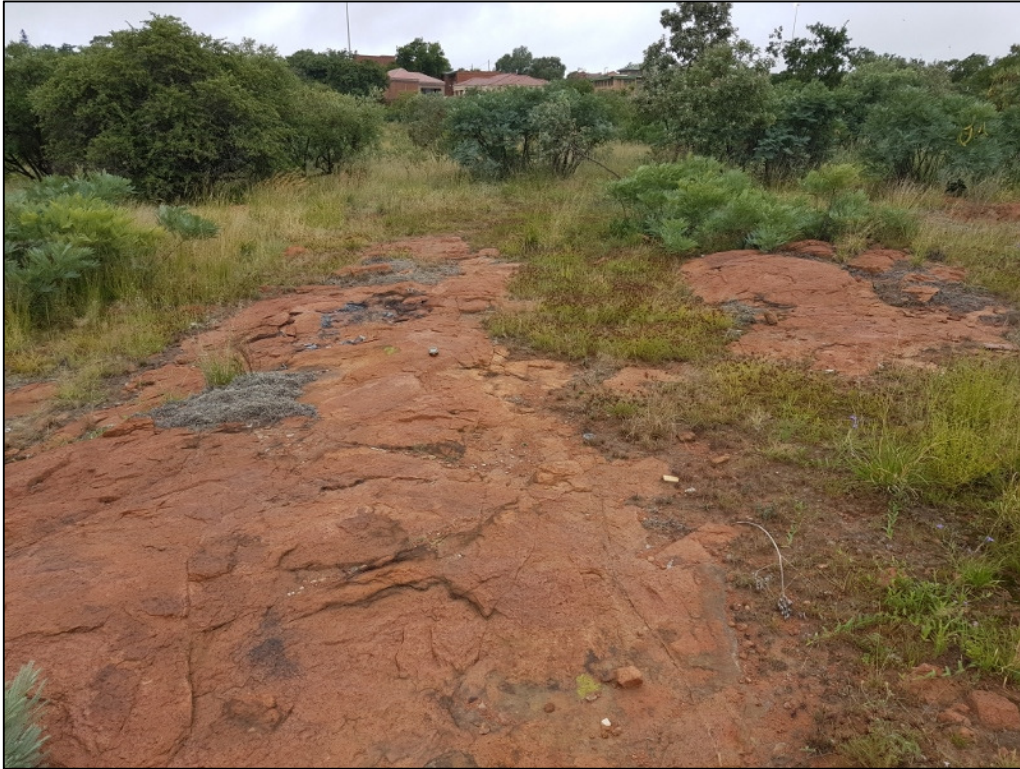
**Photograph 3:** Granophyre outcrops (*Photograph taken near test pit TP09 in an E direction*)

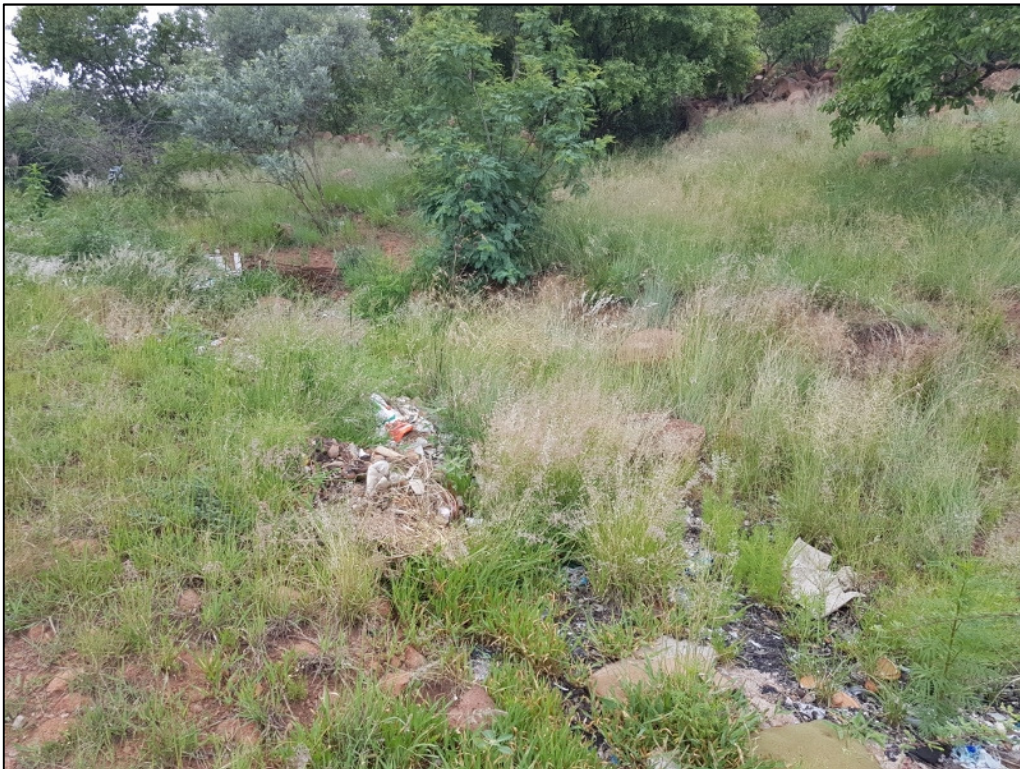
**Photograph 4:** Uncontrolled fill material (*Photograph taken near test pit TP05 in a NE direction*)

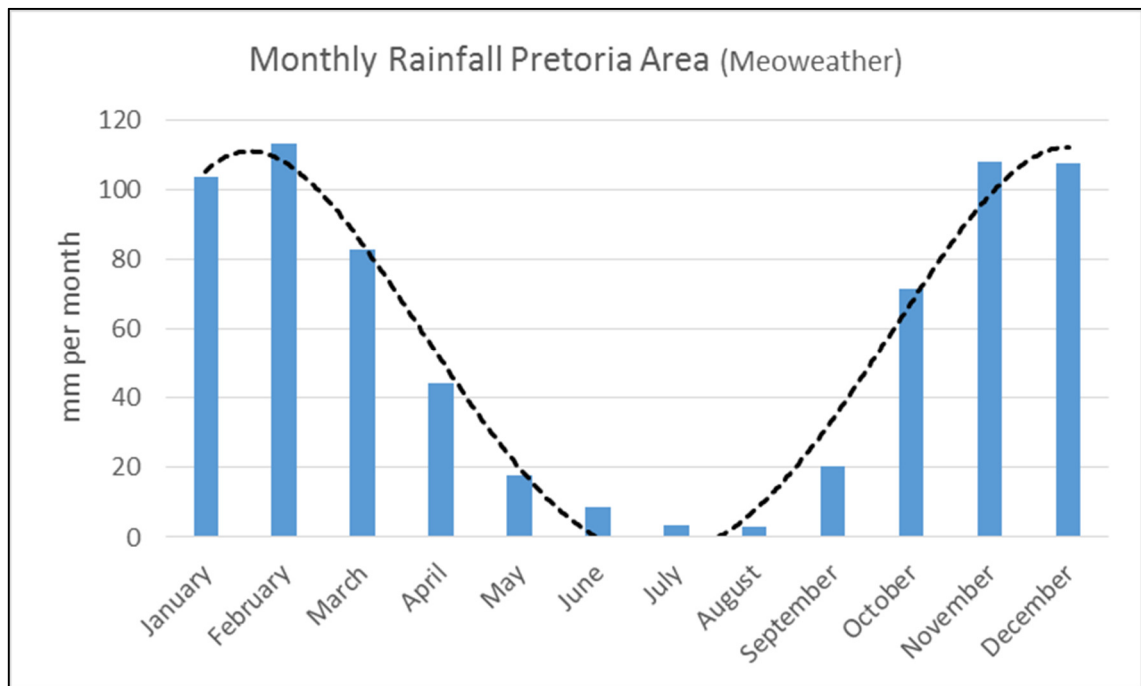
The Pretoria area normally receives approximately 573 mm to 684 mm of rain per year, with most rainfall occurring during the months of November, December, January and February (SA Explorer and Meoweather). The typical monthly rainfall distribution in mm rainfall per month is depicted in **Chart 1**.

**Chart 1:** Rainfall for the Region per Month (Indicated in mm/month)

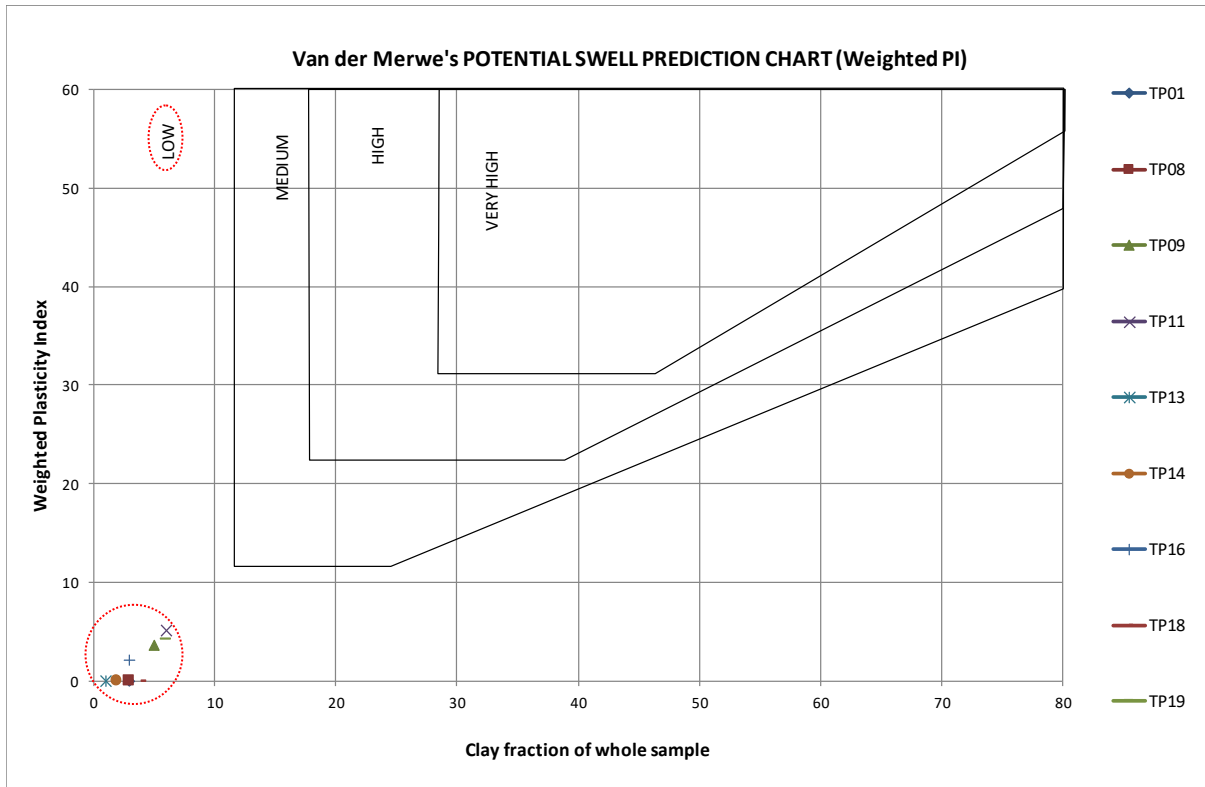
No materials with significant soil heave was identified nor expected to be present on site. Soil heave are considered negligible. The aforementioned is supported by the low recorded swell measured on the compacted samples, swell prediction based on PI and clay fraction of the samples (Van der Merwe’s method) and the visual observations and interpretations. The swell potential chart is depicted in **Chart 2**.

**Chart 2:** Van der Merwe's Swell Prediction Chart

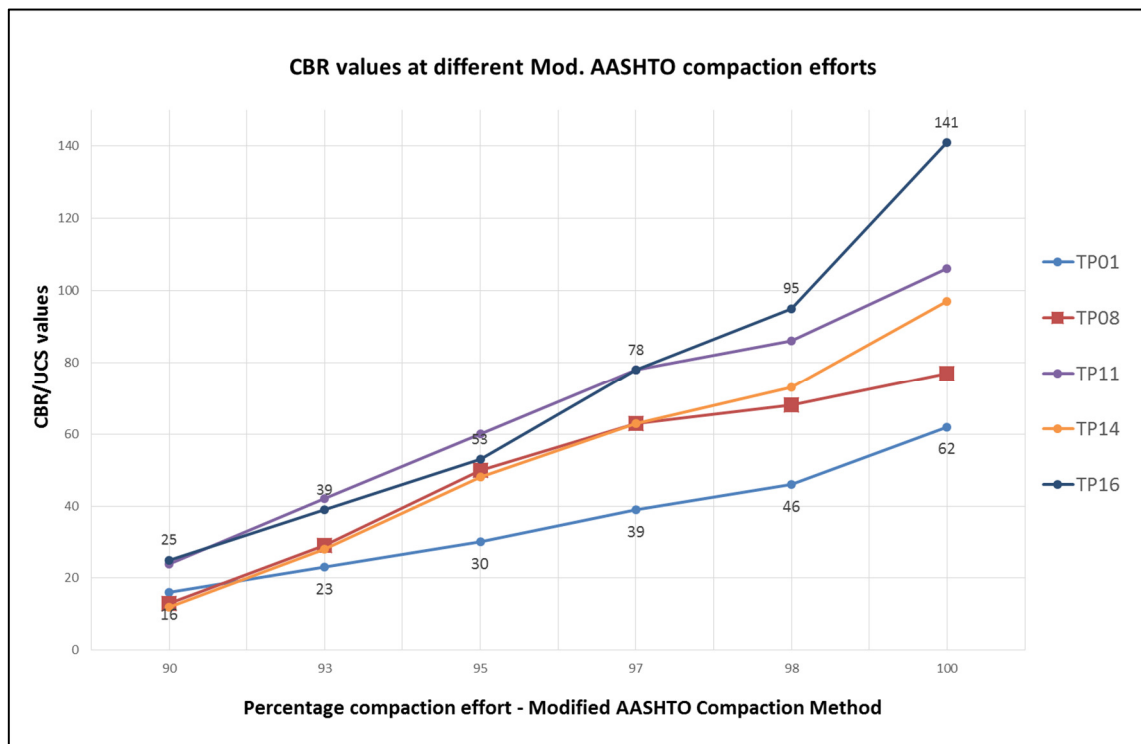
The CBR values increase from ~16/25 at 90 % Mod.AASHTO compaction effort to ~30/60 at 95 % and ~62/141 at 100 % compaction efforts at an optimum moisture content of between 7.8 % and 13.3 %. The maximum dry density of the material tested varied between 1 840 and 2 005 kg/m<sup>3</sup>. The material classifies as “G5” to “G7” as per the TRH14 classification. The increase in CBR values with an increase in compaction effort (Modified AASHTO compaction effort) are visually illustrated in **Chart 3**.

**Chart 3:** Increase in CBR values with Increase in Compaction Effort (Mod.AASHTO)

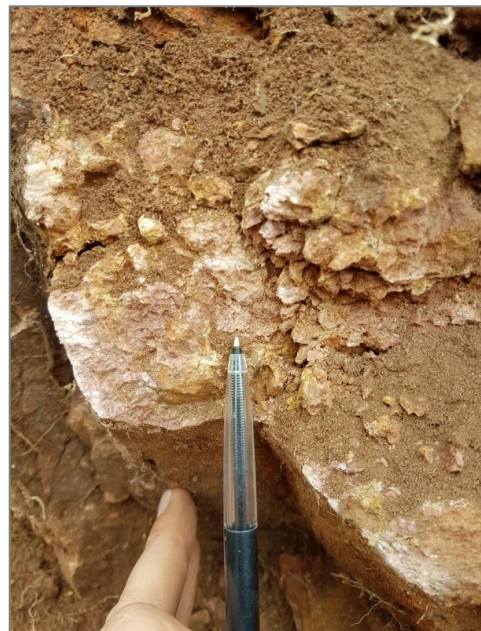
Test Pit no: TP04

Notes: Jointed and fracture highly to medium weathered granophyre.

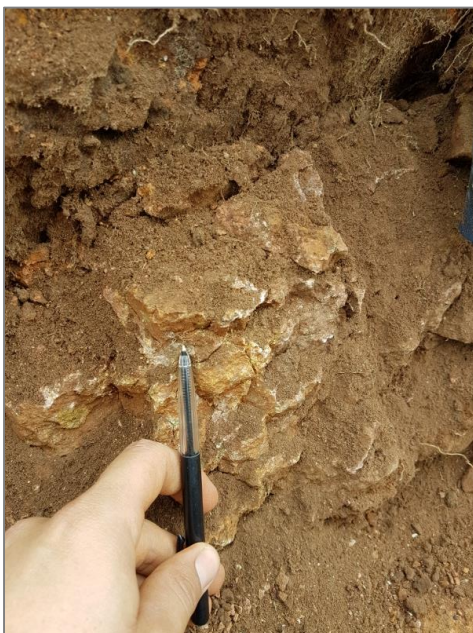
Test Pit no: TP05

Notes: Fractured highly to medium weathered granophyre.

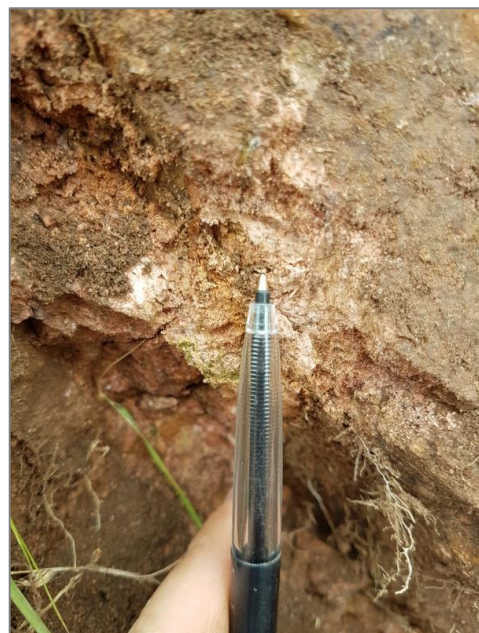
Test Pit no: TP05

Notes: Medium weathered granophyre.

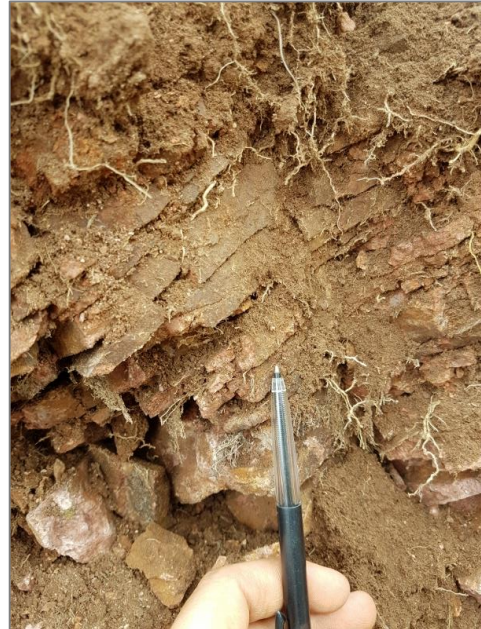
Test Pit no: TP06

Notes: Very closely jointed and fractured medium to highly weathered granophyre.

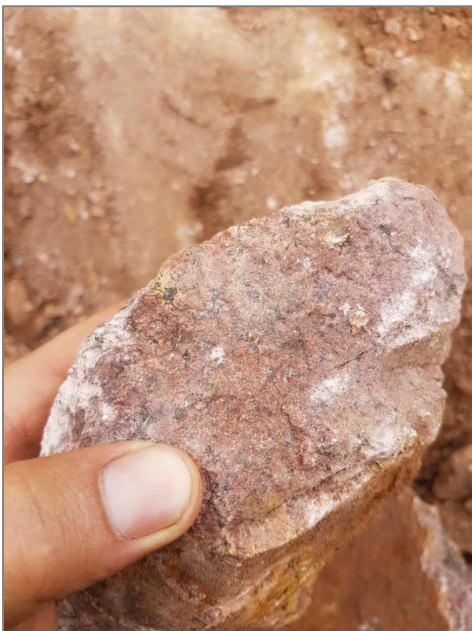
Test Pit no: TP06

Notes: Slightly weathered granophyre.

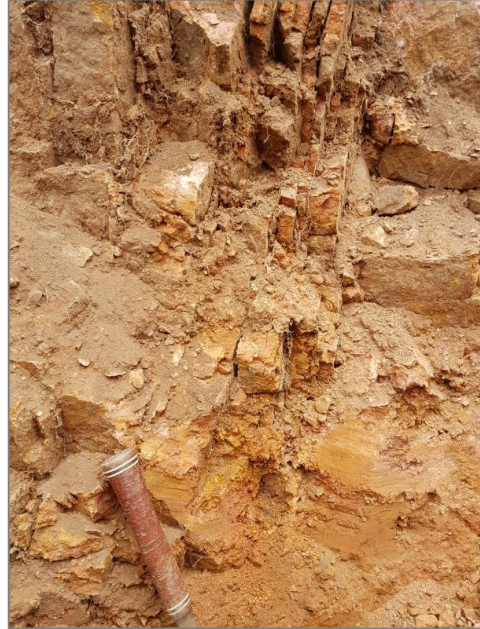
Test Pit no: TP10

Notes: Closely to very closely jointed and fractured granophyre.

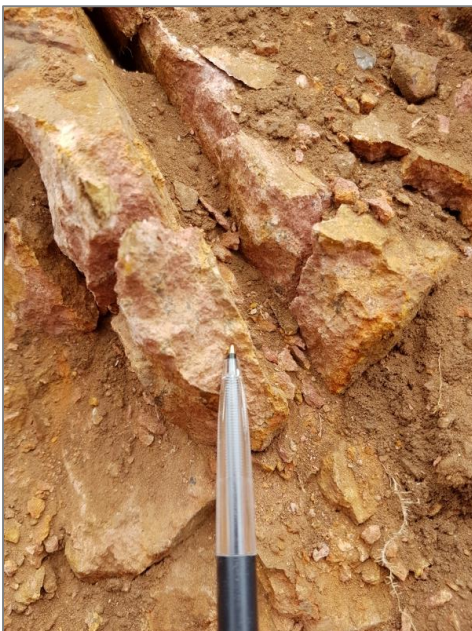
Test Pit no: TP10

Notes: Medium weathered granophyre.

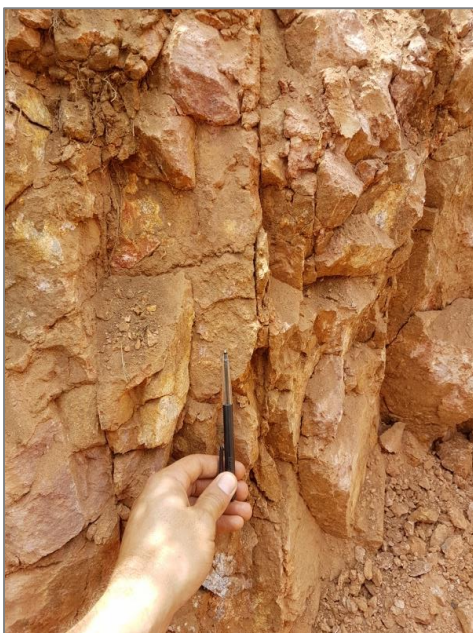
Test Pit no: TP12

Notes: Very closely to closely jointed and fractured granophyre.

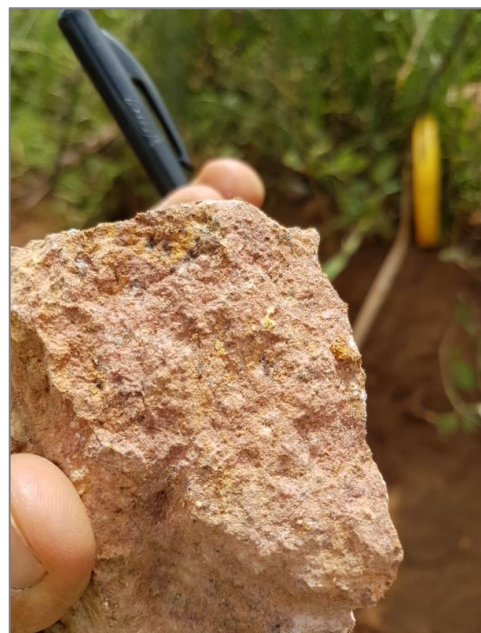
Test Pit no: TP12

Notes: Medium strong granophyre rock.

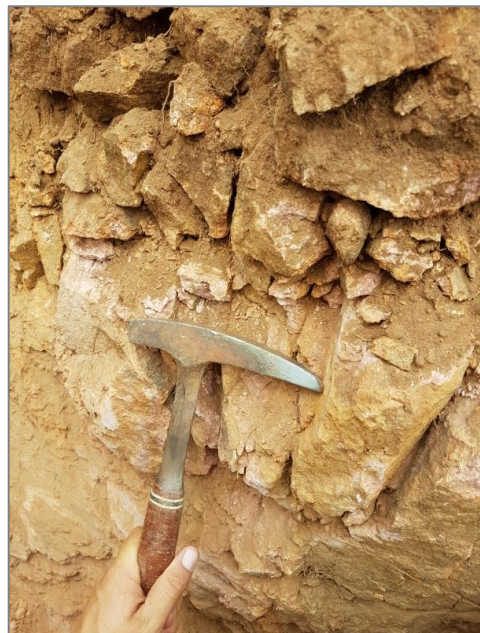
Test Pit no: TP15

Notes: Very closely to closely jointed and fractured granophyre.

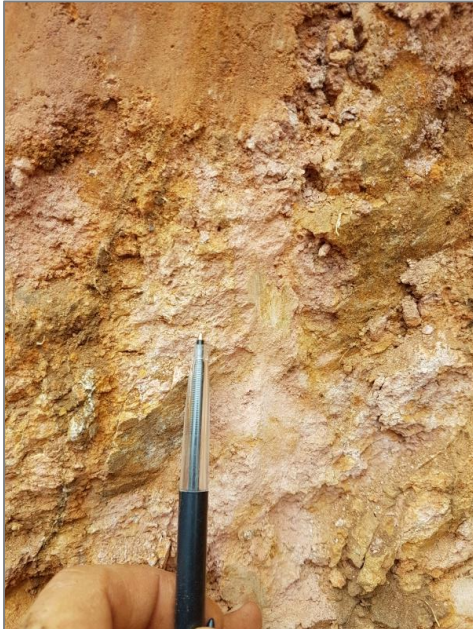
Test Pit no: TP15

Notes: Highly weathered granophyre.

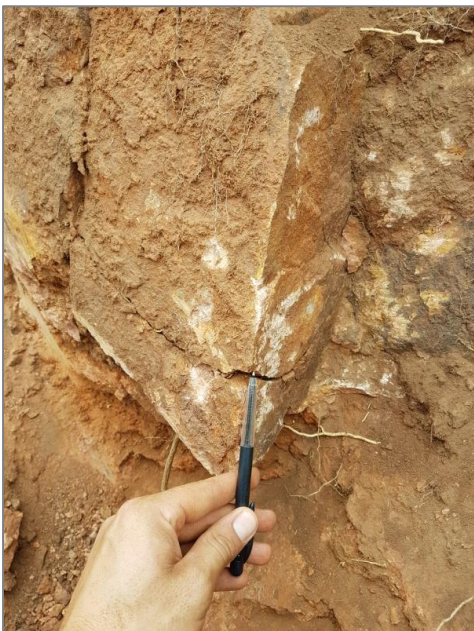
Test Pit no: TP17

Notes: Jointed and fractured granophyre.

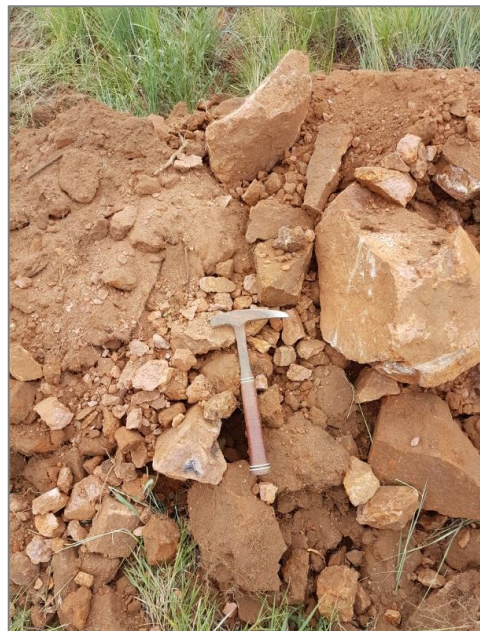
Test Pit no: TP17

Notes: Highly to medium weathered granophyre material excavated.

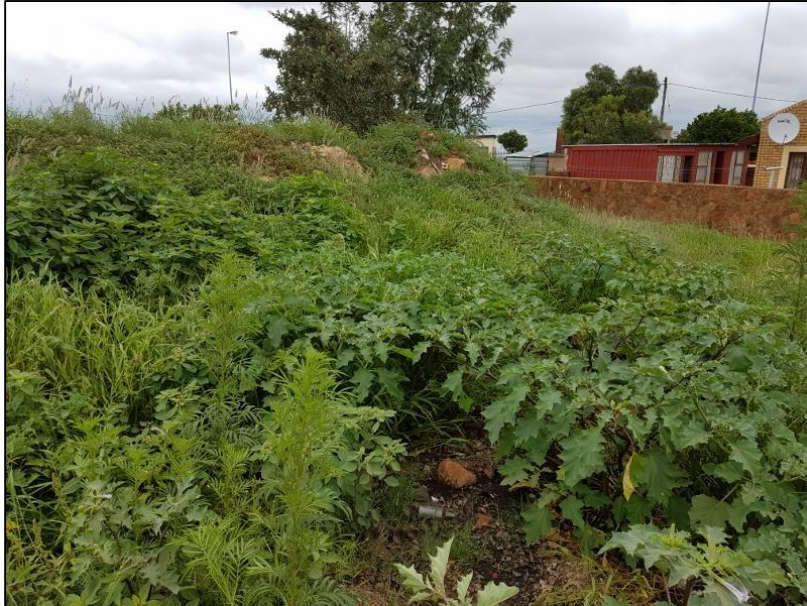
Site Scenery – TP02

Notes: Typical on site conditions. Photograph taken from test pit TP02 in a south-westerly direction. Abundant domestic waste and construction rubble.

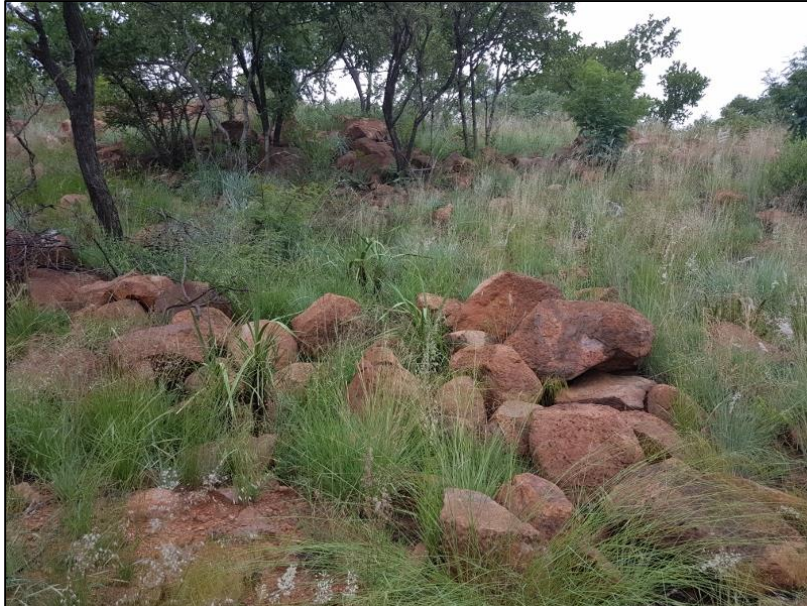
Site Scenery – TP03

Notes: Typical on site conditions. Photograph taken from test pit TP03 in an easterly direction. Prominent granophyre ridge and boulders.

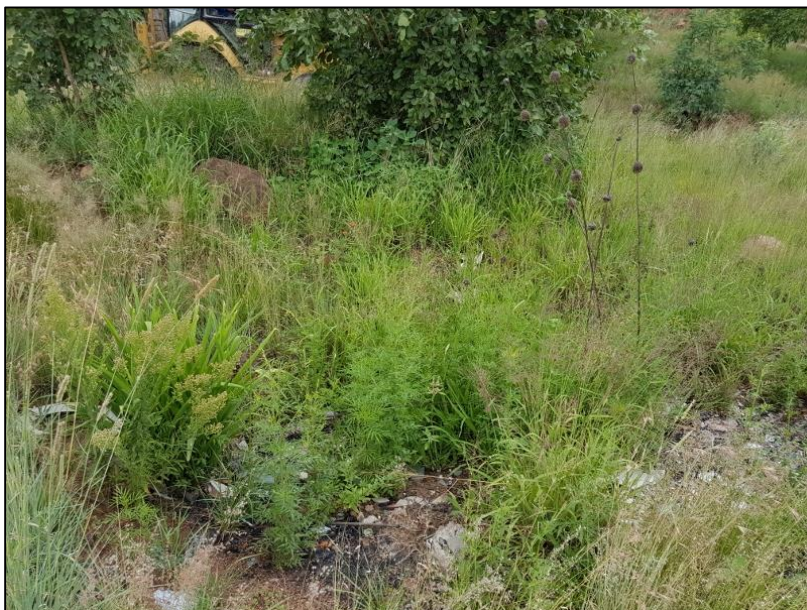
Site Scenery – TP04

Notes: Typical on site conditions. Photograph taken in a north-westerly direction. Old burrows and uncontrolled fill near the test pit.

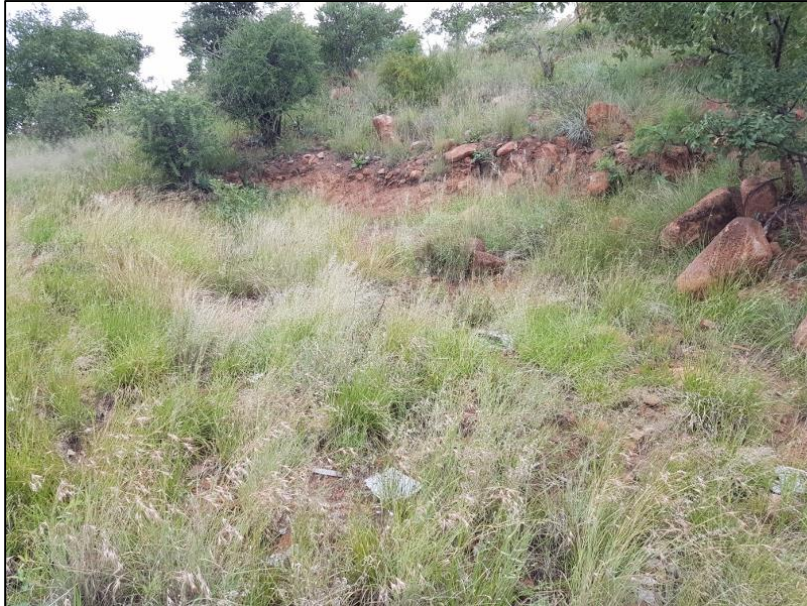
Site Scenery – TP05

Notes: Typical on site conditions. Photograph taken near test pit TP05 in an easterly direction. Old material burrows in the toe of the ridge.

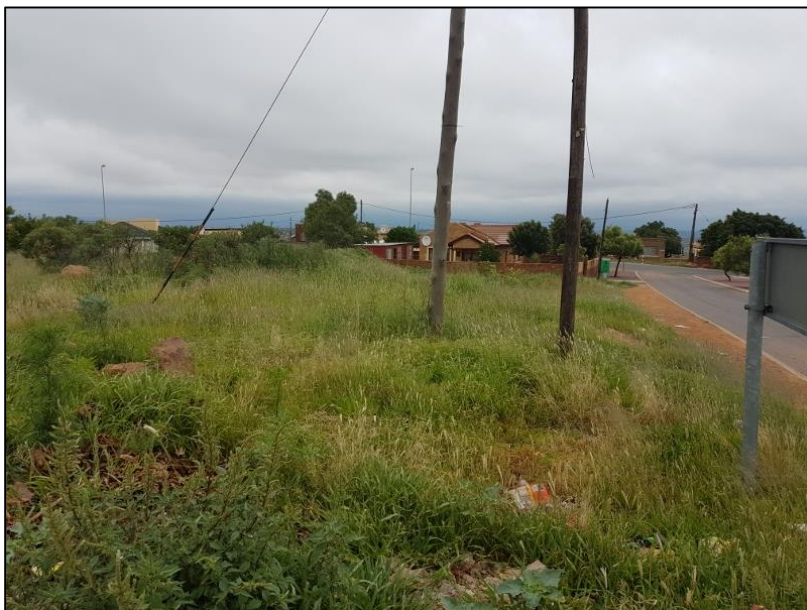
Site Scenery – TP06

Notes: Typical on site conditions. Photograph taken in a westerly direction. Uncontrolled fill near the test pit.

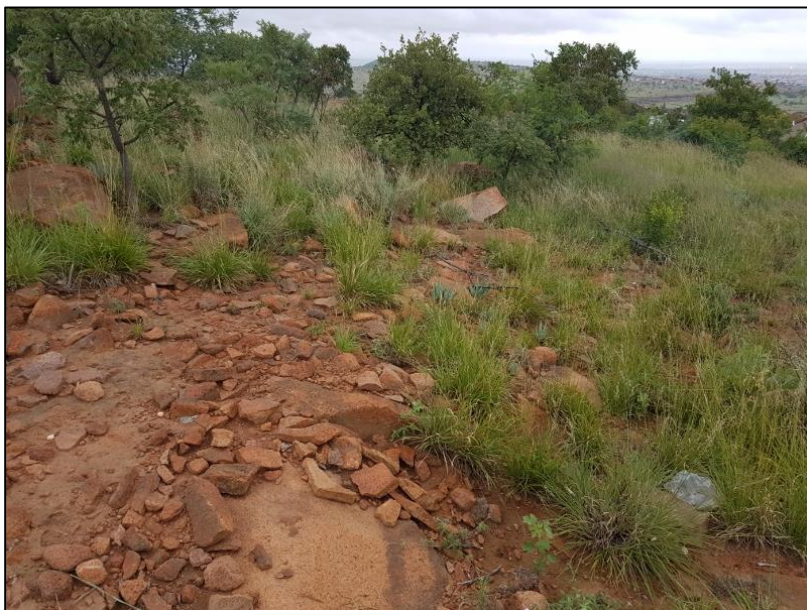
Site Scenery – TP07

Notes: Typical on site conditions. Photograph taken at test pit TP07 in a south-westerly direction. Outcrops and abundant boulders in the vicinity.

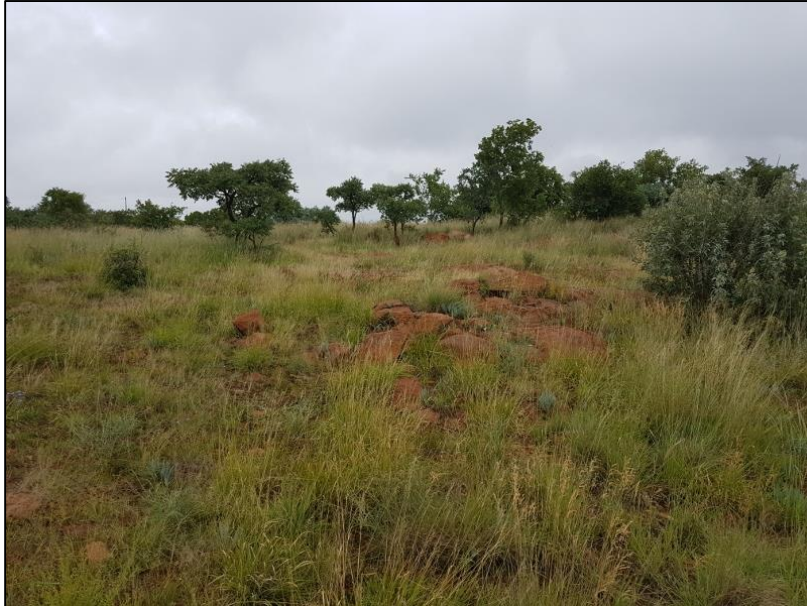
Site Scenery – TP08

Notes: Typical on site conditions. Photograph taken near test pit TP08 in a south-easterly direction. Outcrops and abundant boulders in the vicinity.

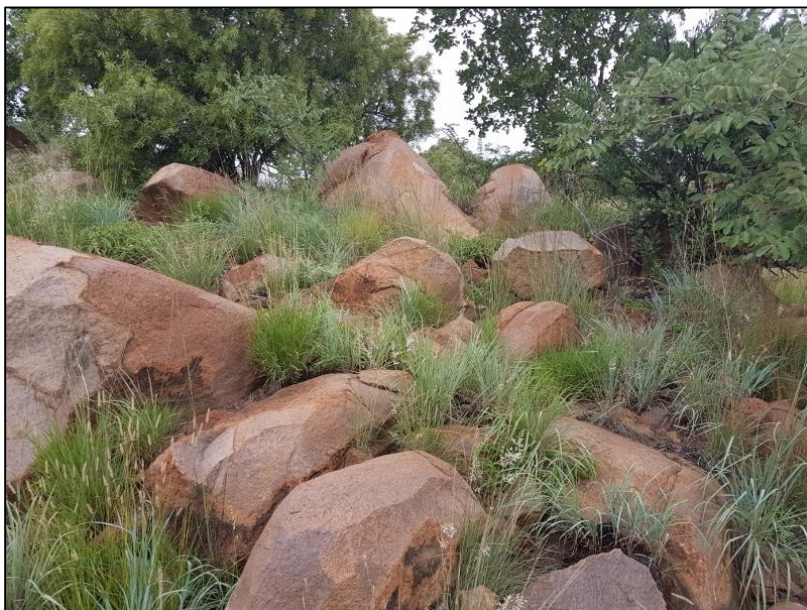
Site Scenery – TP08

Notes: Typical on site conditions. Photograph taken near test pit TP08 in a southerly direction. Outcrops and abundant boulders in the vicinity.

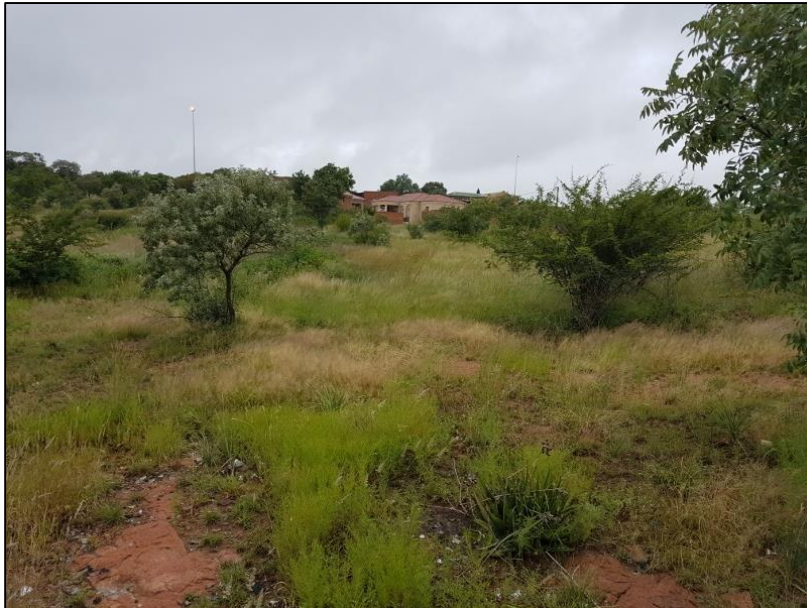
Site Scenery – TP09

Notes: Typical on site conditions. Photograph taken near test pit TP09 in an south-easterly direction. Outcrops in the vicinity.

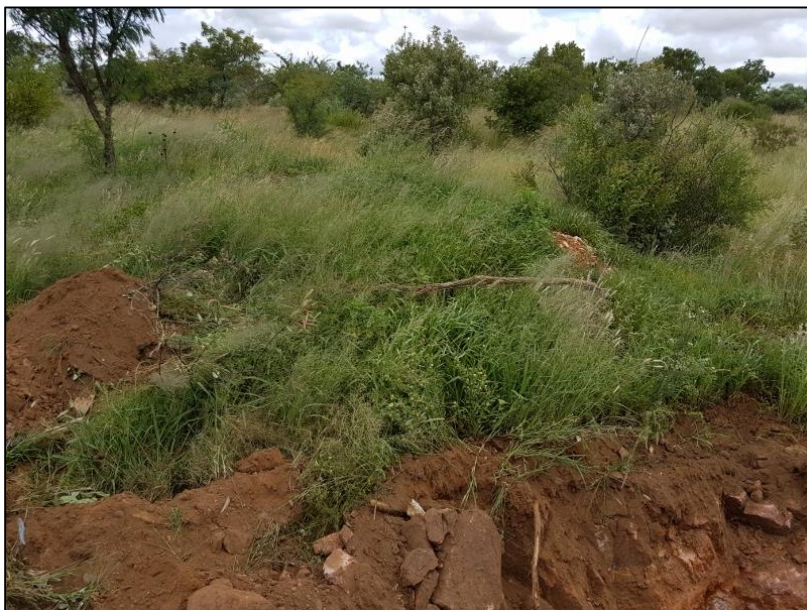
Notes: Typical on site conditions. Photograph taken at test pit TP12 in a southerly direction. Abundant boulders and domestic waste material in the vicinity.

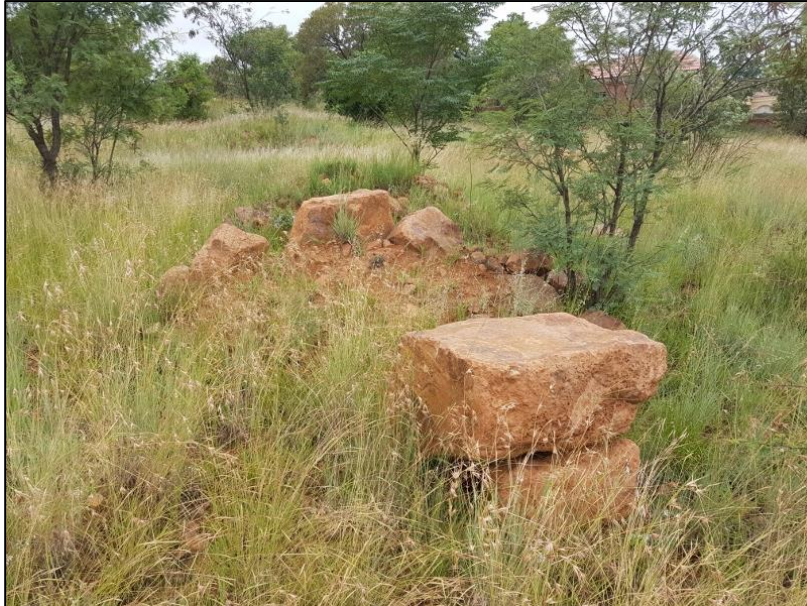
Notes: Typical on site conditions. Photograph taken near test pit TP13 in a easterly direction. Abundant boulders in the vicinity.

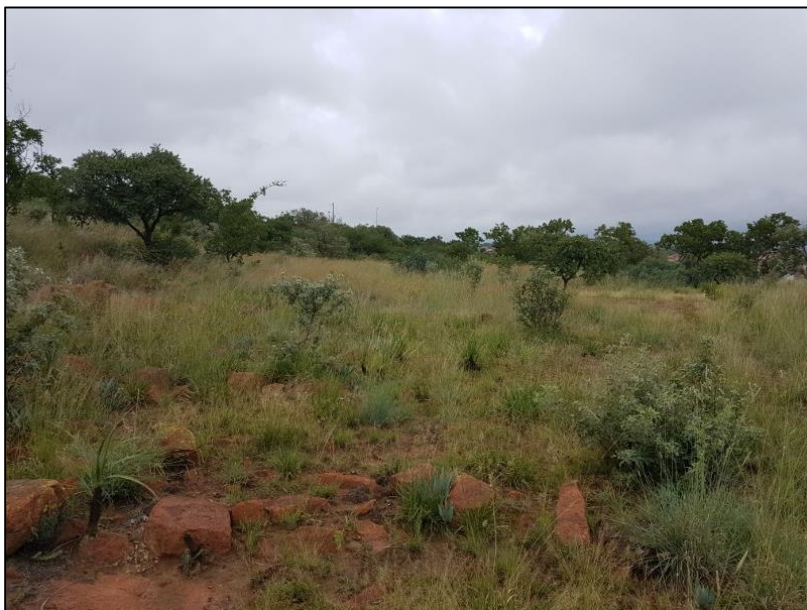
Notes: Typical on site conditions. Photograph taken at test pit TP15 in a southerly direction. Abundant boulders and outcrops in the vicinity.

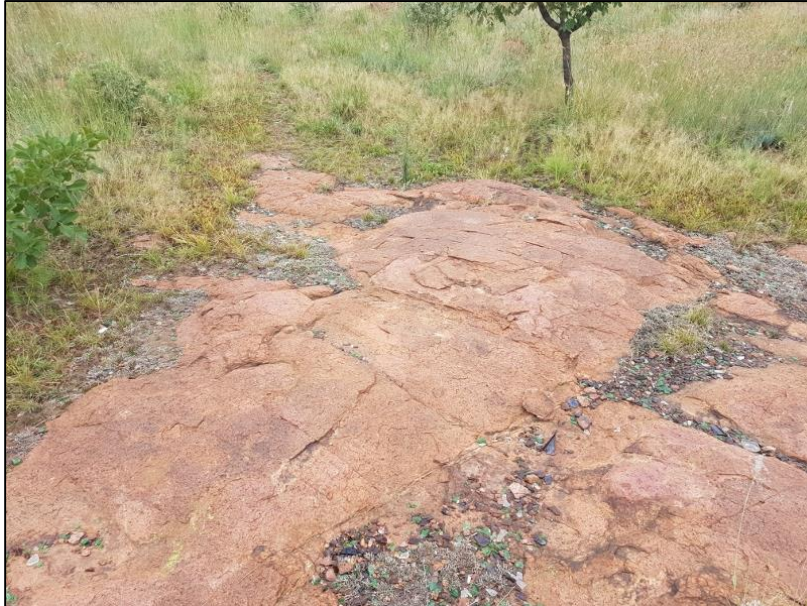
Notes: Typical on site conditions. Photograph taken near test pit TP16 in a easterly direction. Granophyre outcrops.

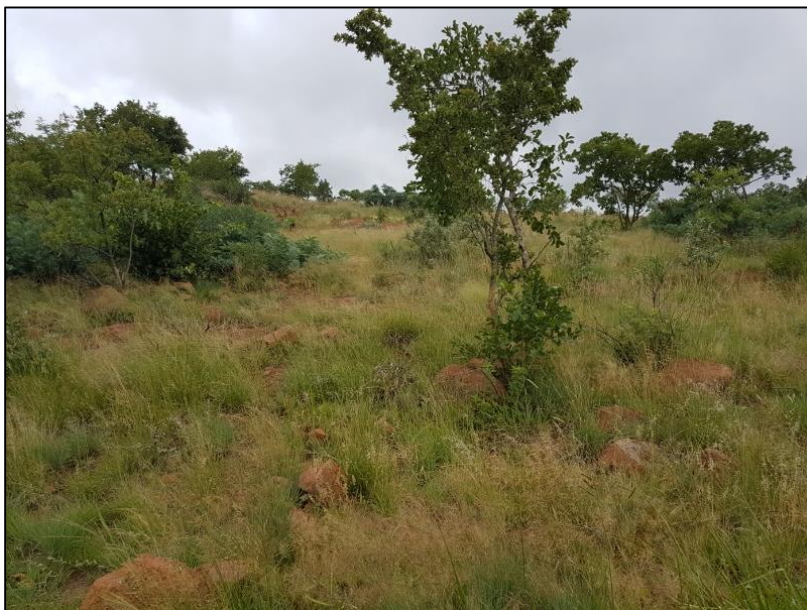
Notes: Typical on site conditions. Photograph taken near test pit TP17 in a northerly direction. Abundant boulders and outcrops in the vicinity.

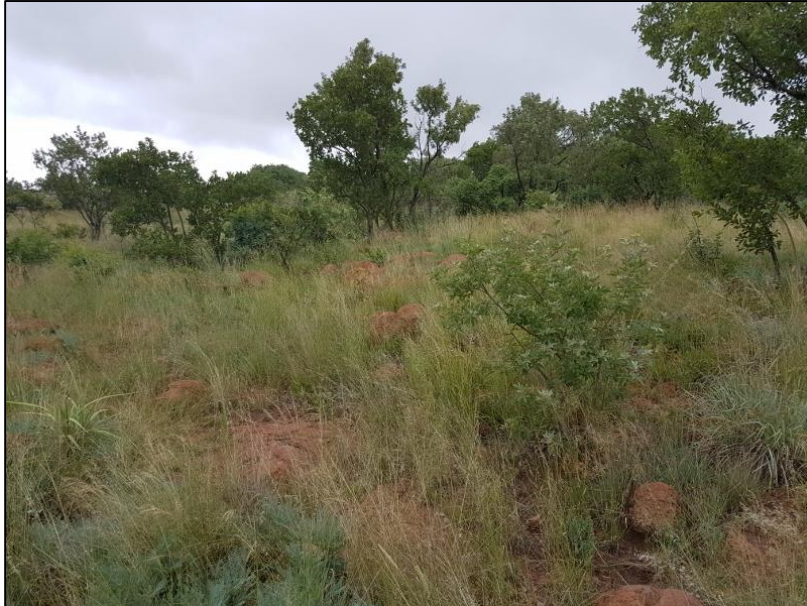
Notes: Typical on site conditions. Photograph taken near test pit TP18 in a south-westerly direction. Abundant boulders and outcrops in the vicinity.

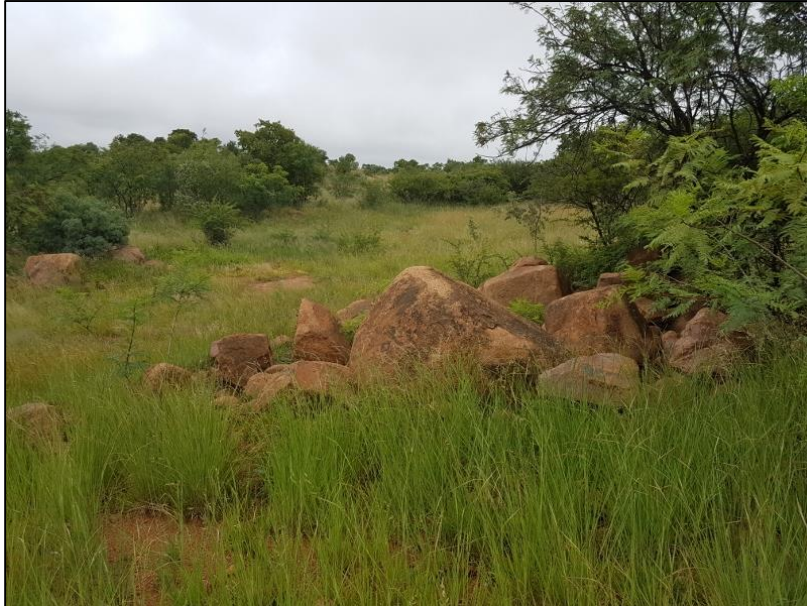
Notes: Typical on site conditions. Photograph taken near test pit TP20 in a north-westerly direction. Abundant boulders and outcrops in the vicinity.

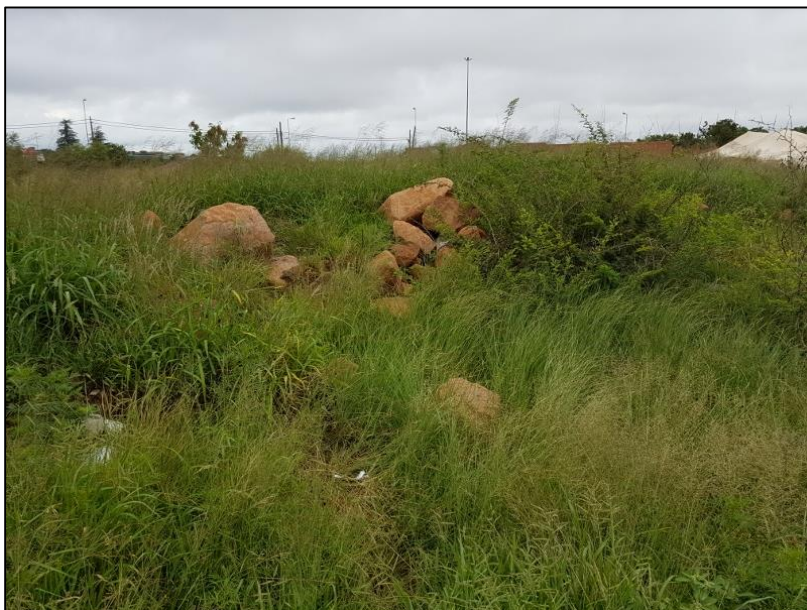
Notes: Typical on site conditions. Photograph taken near test pit TP21 in a south-easterly direction. Abundant boulders and domestic waste material in the vicinity.

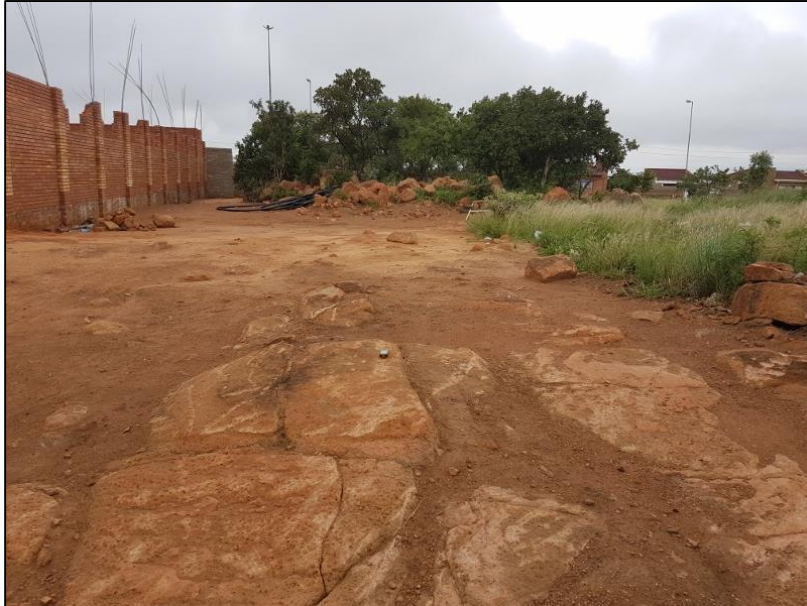
Notes: Typical on site conditions. Photograph taken near test pit TP20 in a southerly direction. Abundant boulders and outcrops in the vicinity.

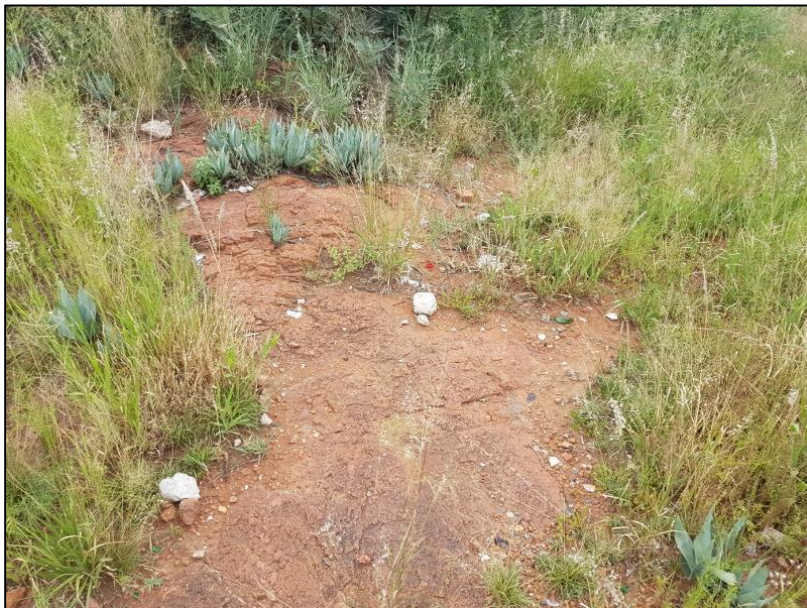
Notes: Typical on site conditions. Photograph taken near test pit TP21. Granophyre outcrop to the west of the test pit.
