Geotechnical Assessment Study for the proposed construction and maintenance of New System 1 and associated infrastructure at Rand Water Vereeniging Treatment Works. *Note the report was compiled in 2019 but is still applicable for this project.*

GEOTECHNICAL INVESTIGATION

RAND WATER
VEREENIGING PUMPING STATION:
GEOTECHNICAL INVESTIGATION
225ML SEDIMENTATION TANK, FLOCCULATOR AND ASSOCIATED SYSTEM 1 PIPELINES

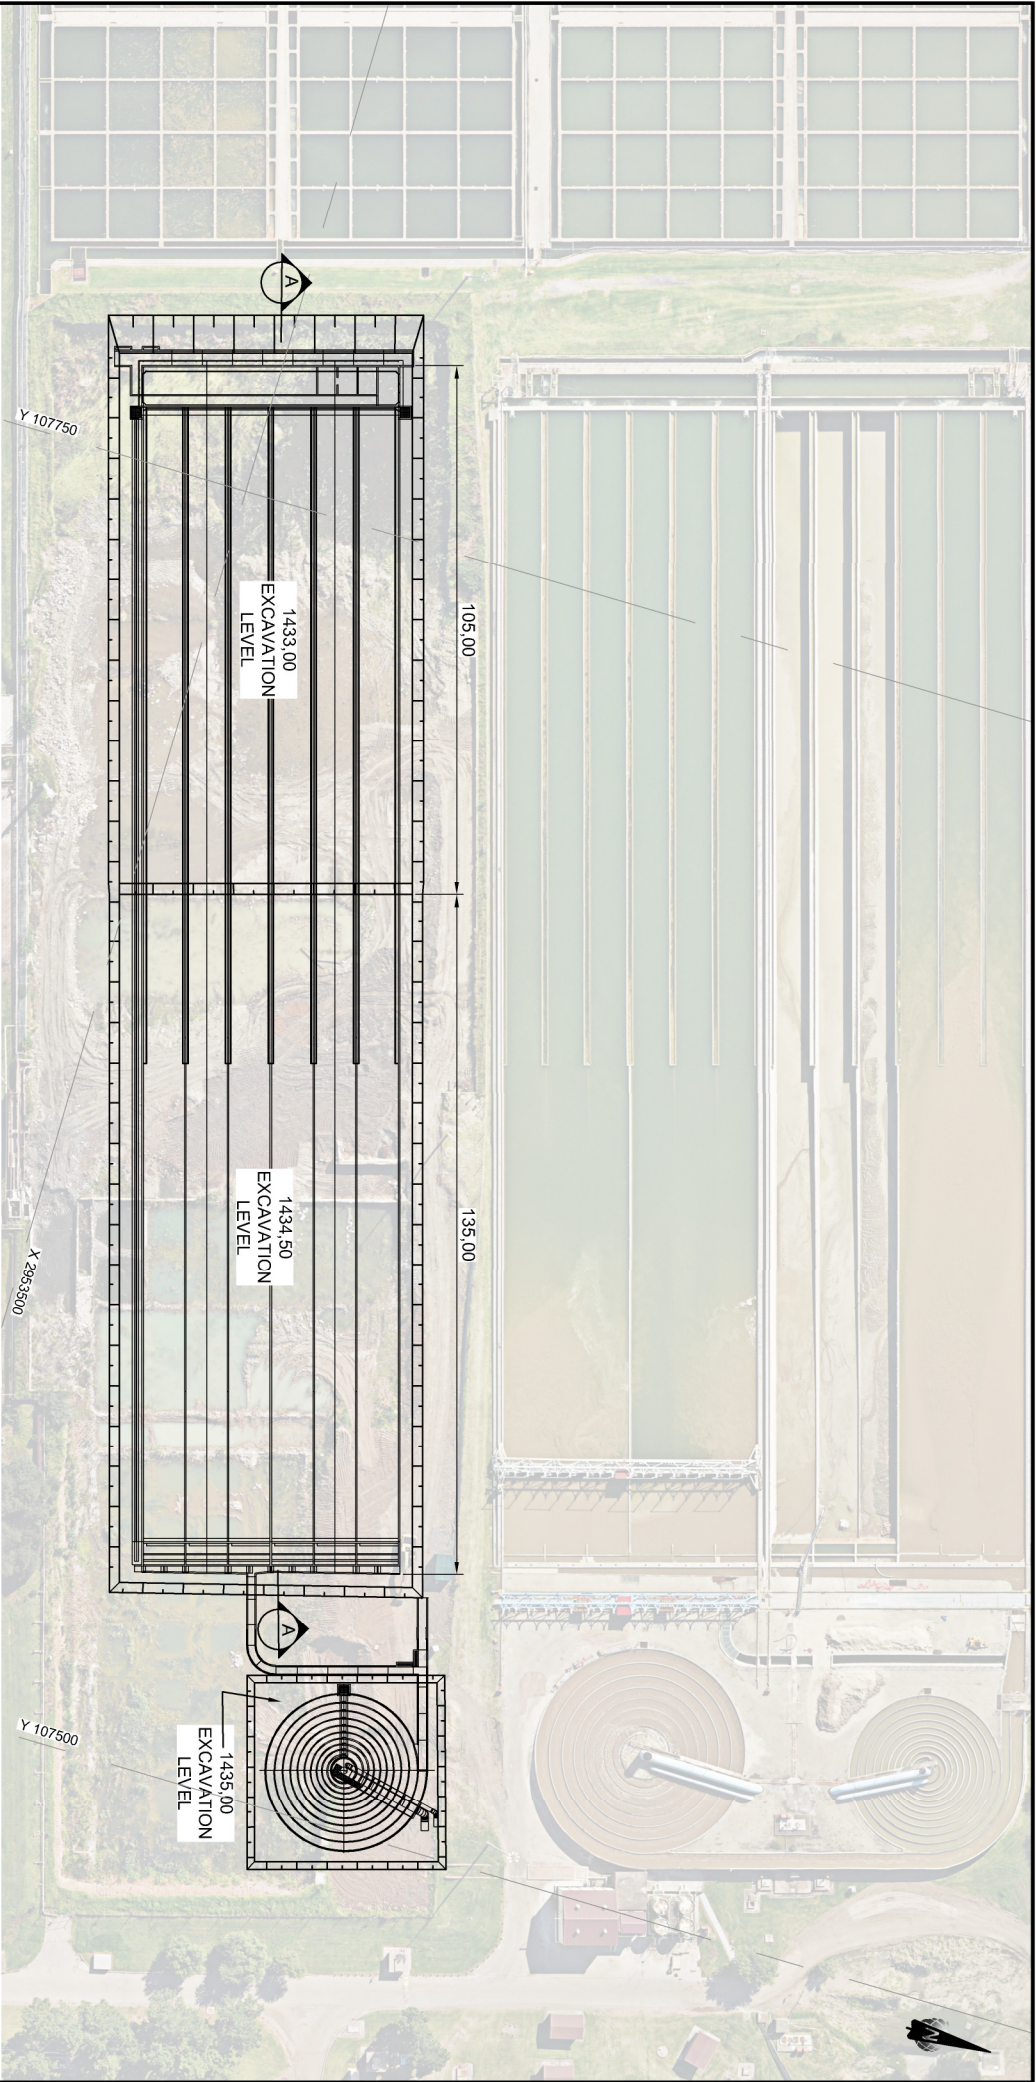
PROPOSED EXCAVATION PLAN (SCHEMATIC)

0.5m THICK G6 BACKFILL

- From a distance of 135m to 240m from the east wall excavate to the 1433.00 level to reach firm clayey silt.
- Compact the excavation floor to 90% of Modified AASHTO maximum dry density (MDD) at optimum moisture content (OMC).

- Backfill the excavation with imported rockfill up to 0,5m below the tank founding levels. Place the rockfill in maximum 500mm thick layers and compact with a minimum of 5 passes with a 10-ton pad foot roller. The maximum rock size must not exceed 350mm.

- Excavate to the 1435.00 level to reach medium dense clayey sand and remove all material to spoil.
- Compact the excavation floor to 90% of Modified AASHTO MDD at OMC.
- Backfill the excavation with imported rockfill up to 0,5m below the flocculator founding levels. Place the rockfill in maximum 500mm thick layers and compact with a minimum of 5 passes with a 10-ton pad foot roller. The maximum rock size must not exceed 350mm.
- Place imported G6 quality material on the rockfill and compact in maximum 200mm thick layers to 95% of Modified AASHTO MDD at OMC up to the required flocculator floor levels.
- Construct a 50mm thick blinding layer on the engineered backfill. The maximum allowable bearing pressure should not exceed 150kPa to limit settlement to less than 10mm.

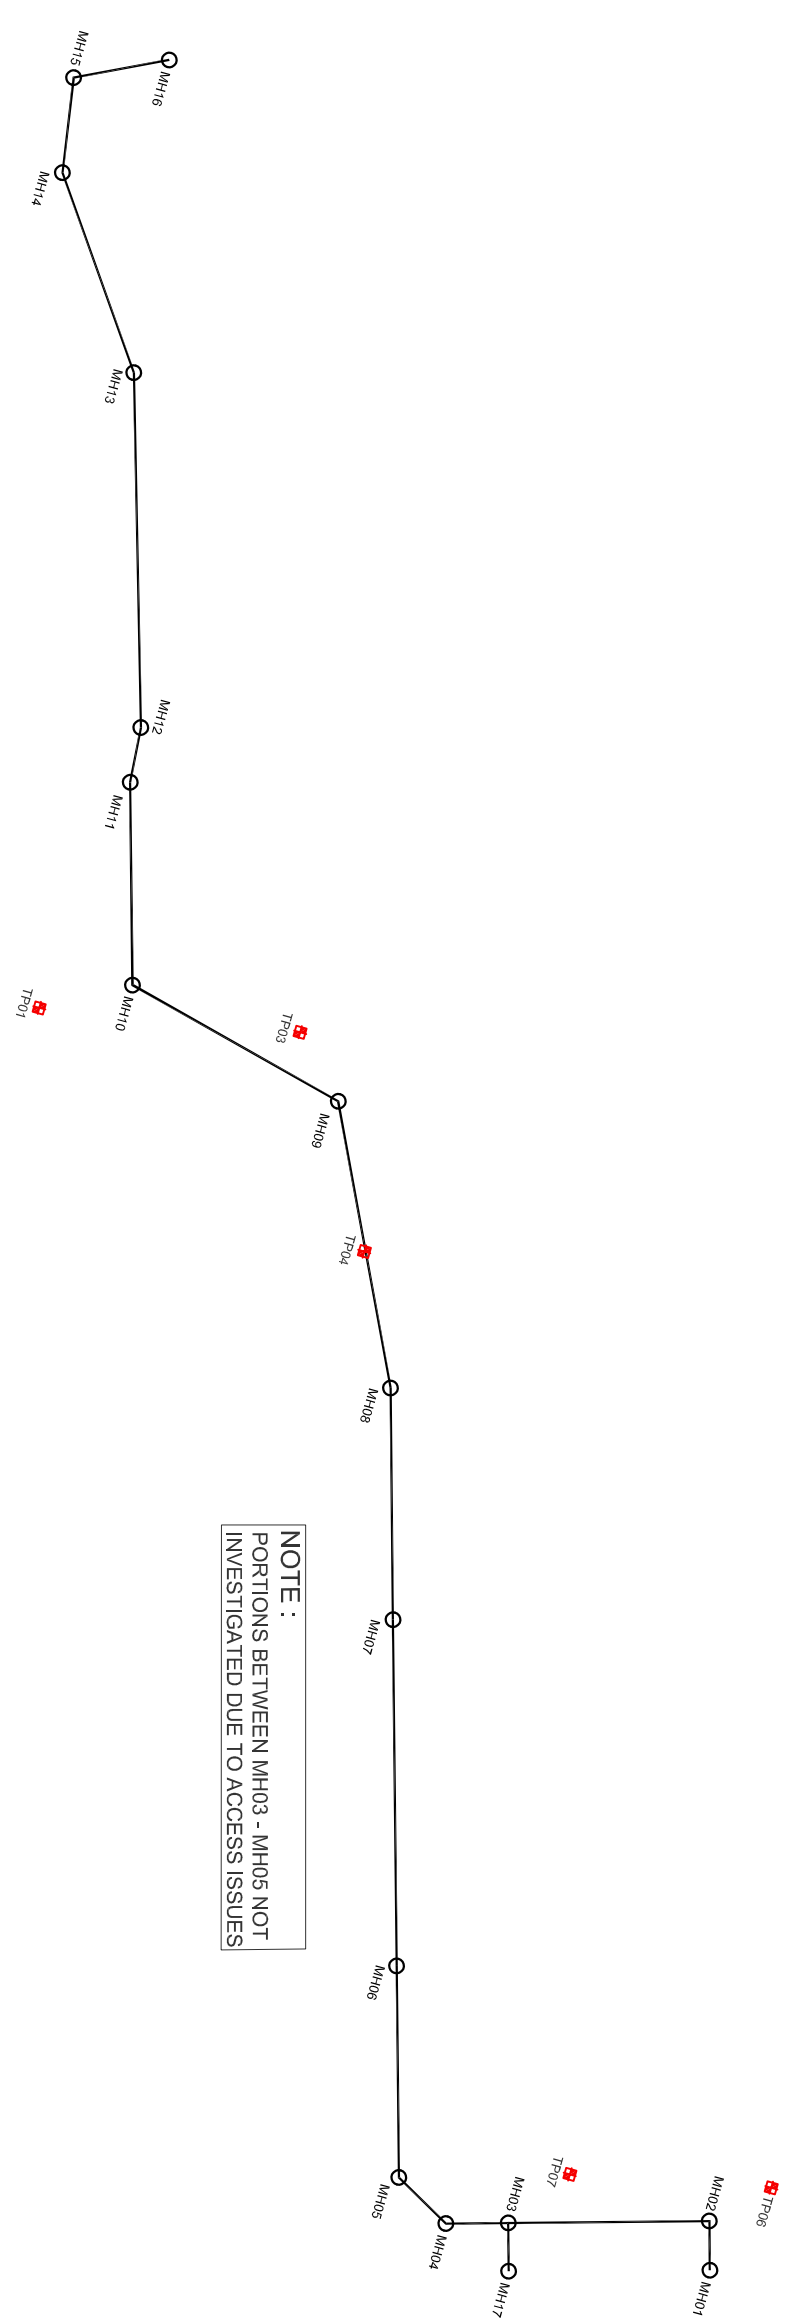
NOTE :
PORTIONS BETWEEN MH03 - MH05 NOT INVESTIGATED DUE TO ACCESS ISSUES

- FILL : SOFT
- ALLUVIUM : SOFT

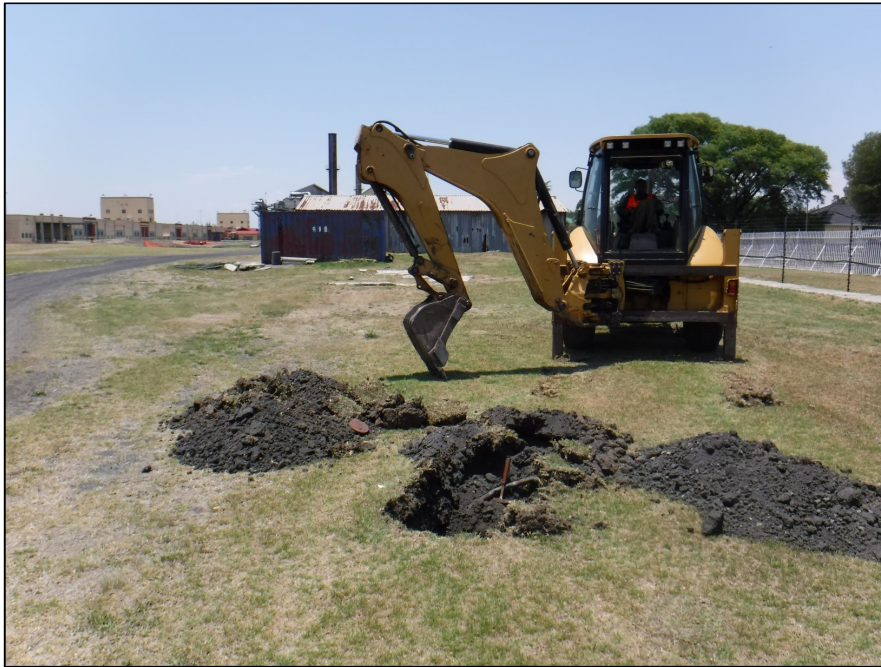
Plate 1. TP1 excavation with a TLB in progress.

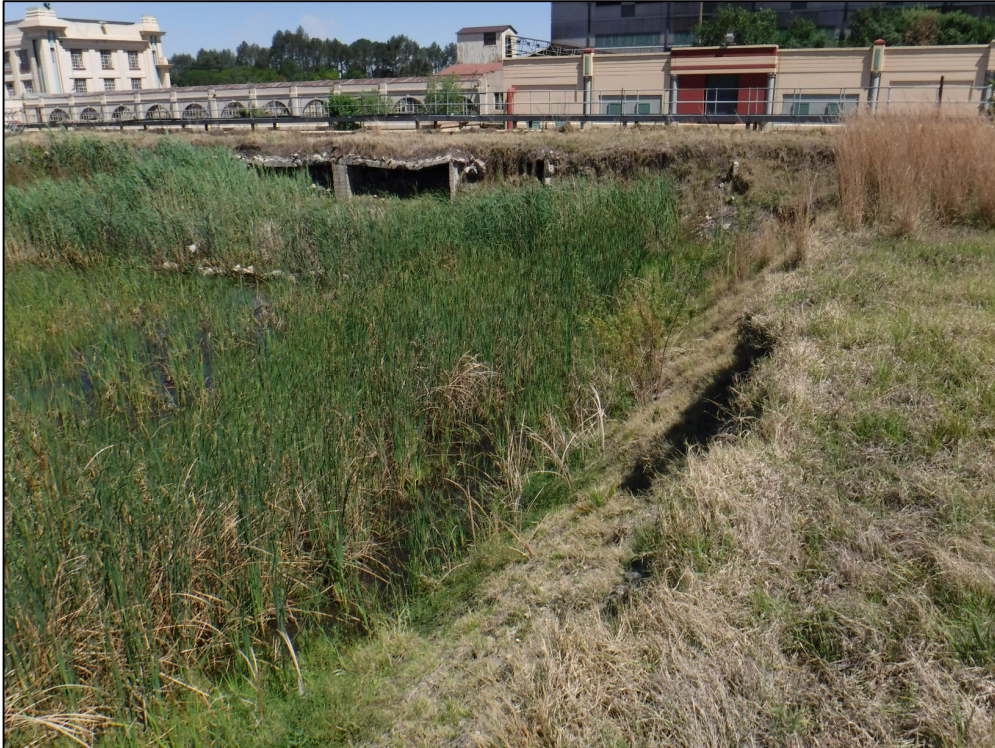
Plate 7. North-western corner of old System 1A excavation, which is partially filled with water.

The old System 1A excavation is approximately 3m to 4m deep and 310m in length by 45m to 75m in width and has been fenced off. The area is highly disturbed and the old System 1A structures have only been partially demolished. The excavator test pits were excavated at the floor level of the excavation and these have subsequently been surveyed. Historical satellite imagery corroborates the disturbance in this area, and the origin of the upper expansive soils remains uncertain.

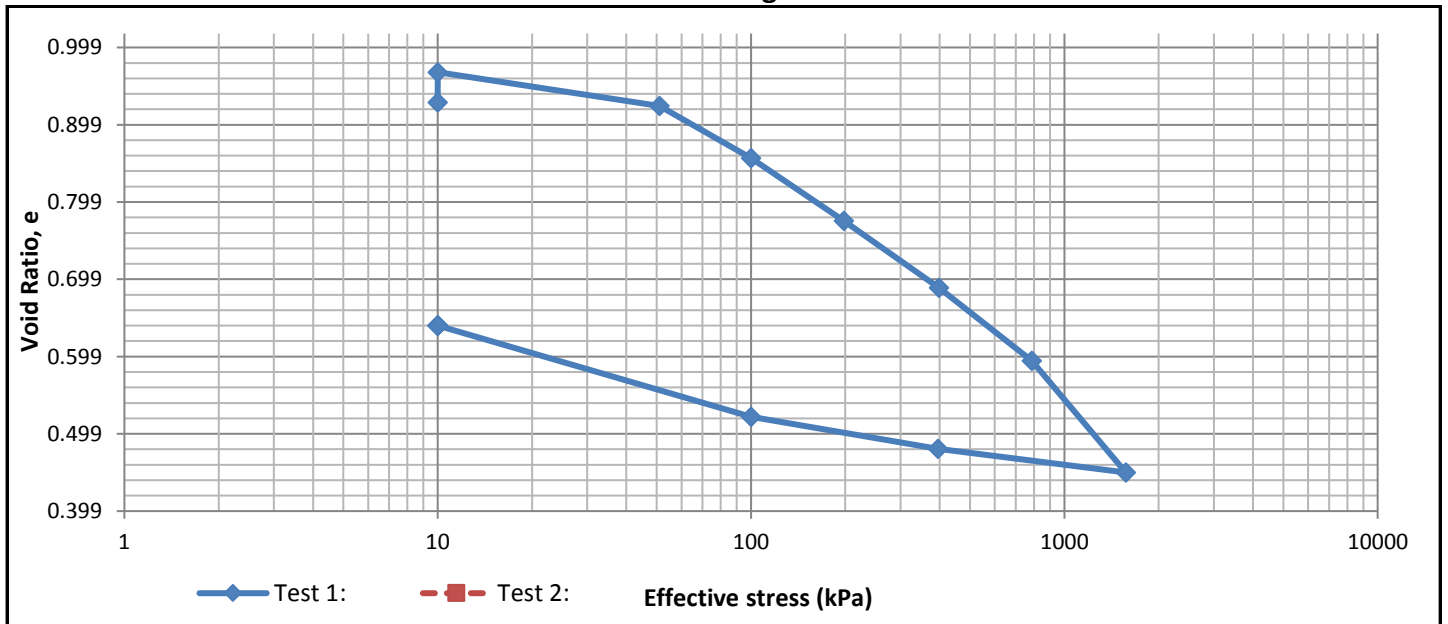
CONSOLIDATION TEST RESULTS - BS 1377: Part 5

Strain Log Stress

Void Ratio Log Stress
