SPECIALIST DECLARATION FORM – AUGUST 2023

Geotechnical Assessment Study for Panfontein _Rand Water

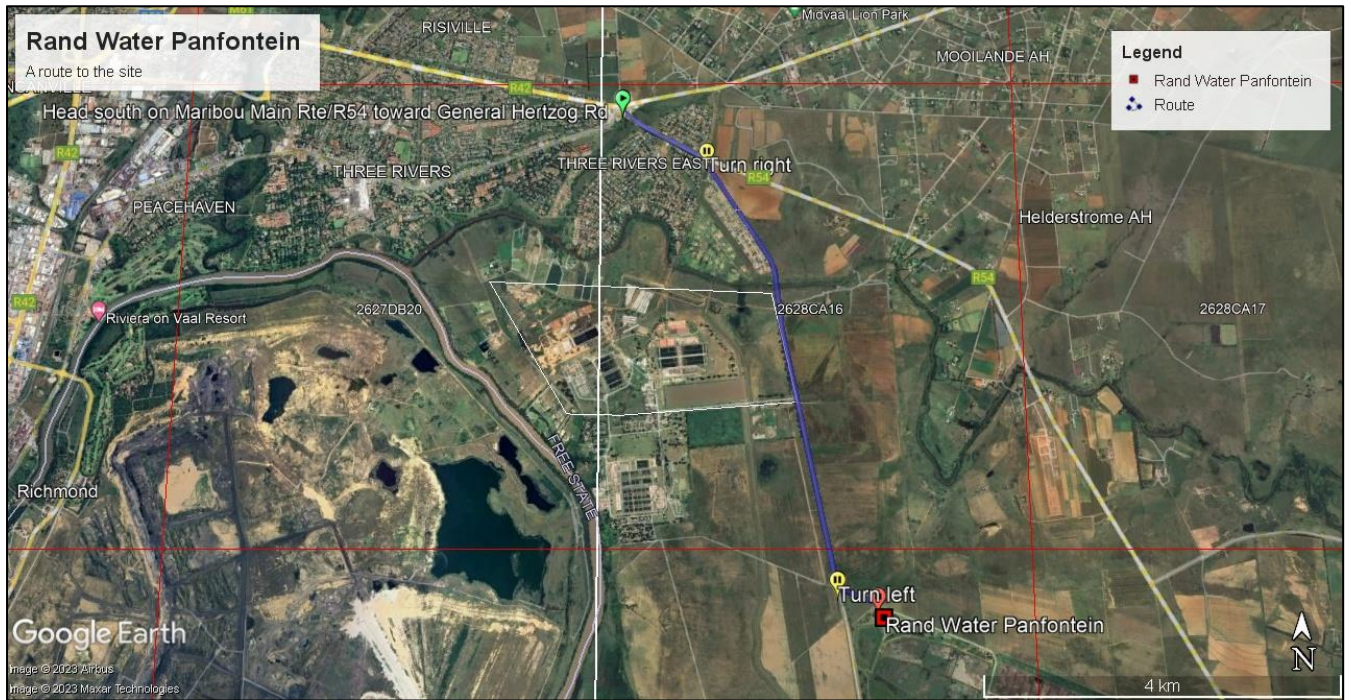
Figure 1 : Aerial view image of one of the routes to Panfontein Rand Water extracted from Google Earth

This facility's main entrance coordinates in Longitude and Latitude, Datum WGS 84 are 26°42'21.1"S and 28°01'56.1"E respectively. To get to the main entrance of Panfontein Rand Water, one will have to drive along R54 Road for about 1.2km from the intersection with R42 Road. This will lead to another junction whereby R54 Road forms another intersection with a tar road leading further southward. Driving for about 5.4km along this road will lead to a left turn on to the gravel road. A 500m drive on the gravel road will lead to the main entrance. **Figure 1** illustrates the route mentioned above.

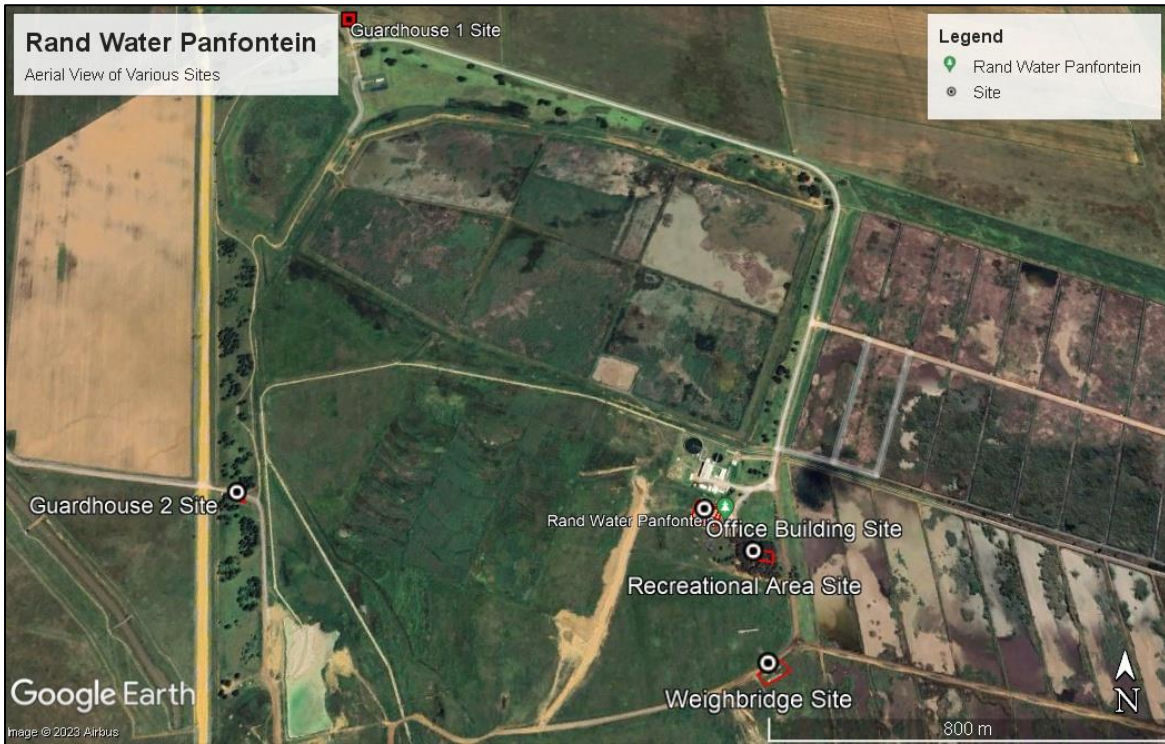
Figure 2: Aerial view of various sites extracted from Google Earth

The investigated area is a Rand Water sludge disposal facility with a well secured controlled access. The site is easily accessible on properly constructed roads. Within the establishment, there are several sites denoted, for the sake of reference in this report, as Guardhouse 1, Guardhouse 2, Office Building, Recreation Area and Weighbridge as shown on **Figure 2 below**. Each site will be described independently on the following sections.

The positions of the test pits were recorded using a Garmin GPS handset and are pinned on the Google Earth images on **Figures 2 to 7 above**. Test pits were profiled by an engineering geologist and their profiles along with the respective pictures are included in **Appendix A** of this report.

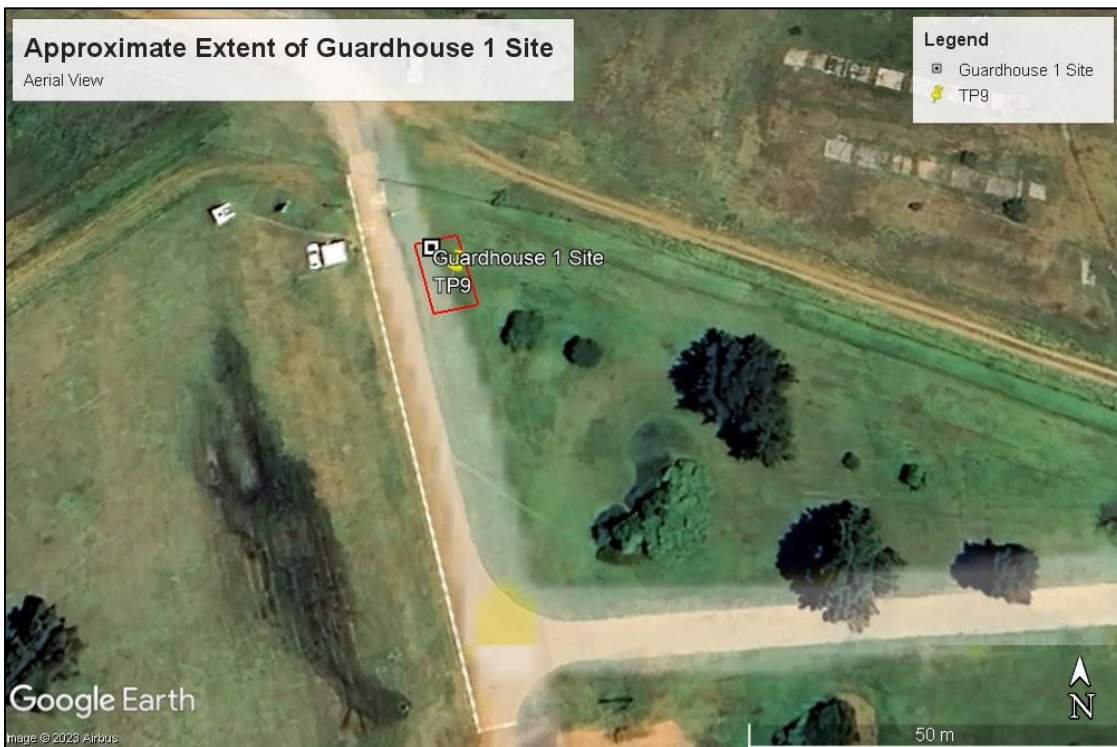
Figure 3: Aerial view of the Guardhouse 1 extracted from Google Earth

Guardhouse1 will be constructed near the main entrance on the eastern side of the internal road. **Figure 3 below** shows aerial view of the site, extracted from Google Earth images.

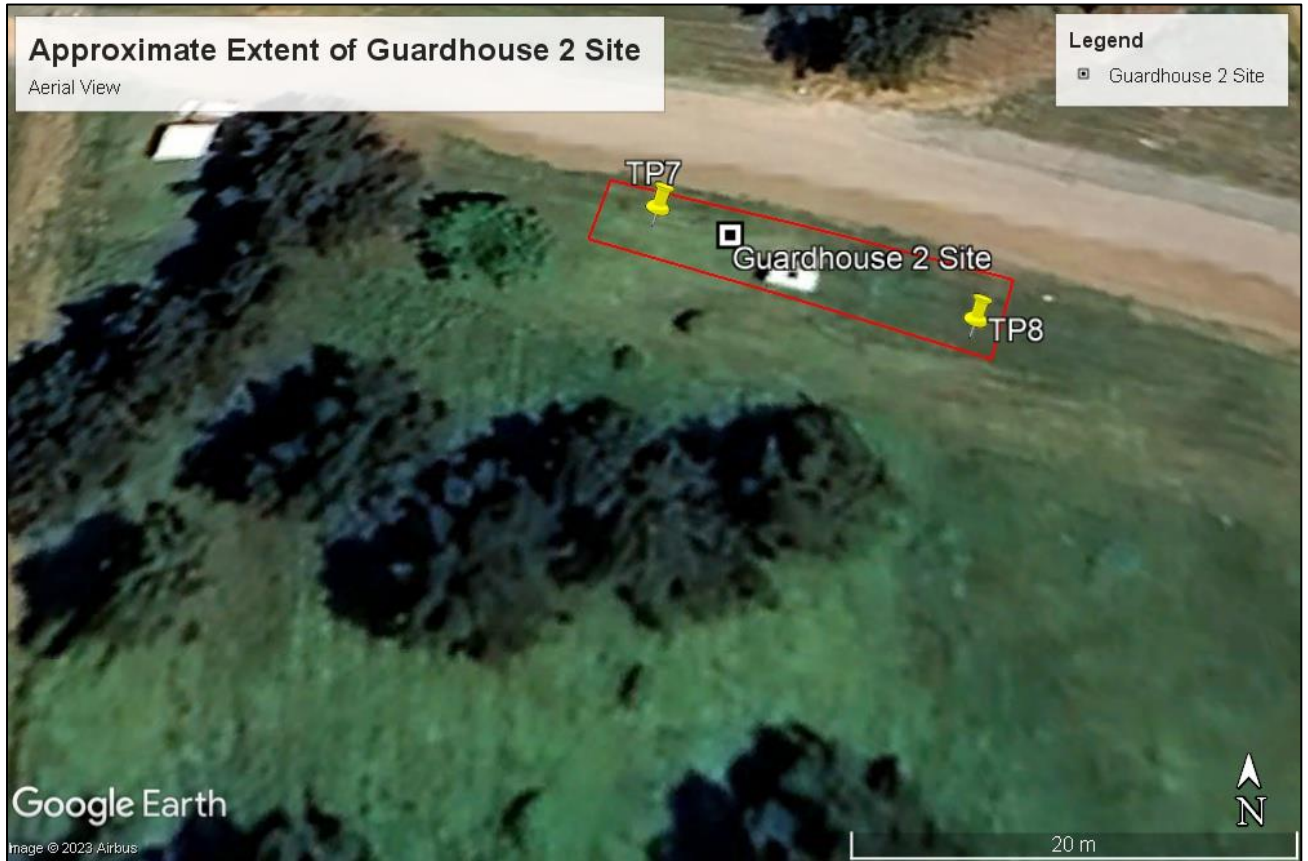
Figure 4: Aerial view of Guardhouse 2 site extracted from Google Earth

Guardhouse 2 will be constructed near one of the entrances on the south-western side of the internal road. There are trees within a close proximity of the site where the guardhouse will be constructed.

Figure 4 below shows an aerial view of the site, extracted from Google Earth images.

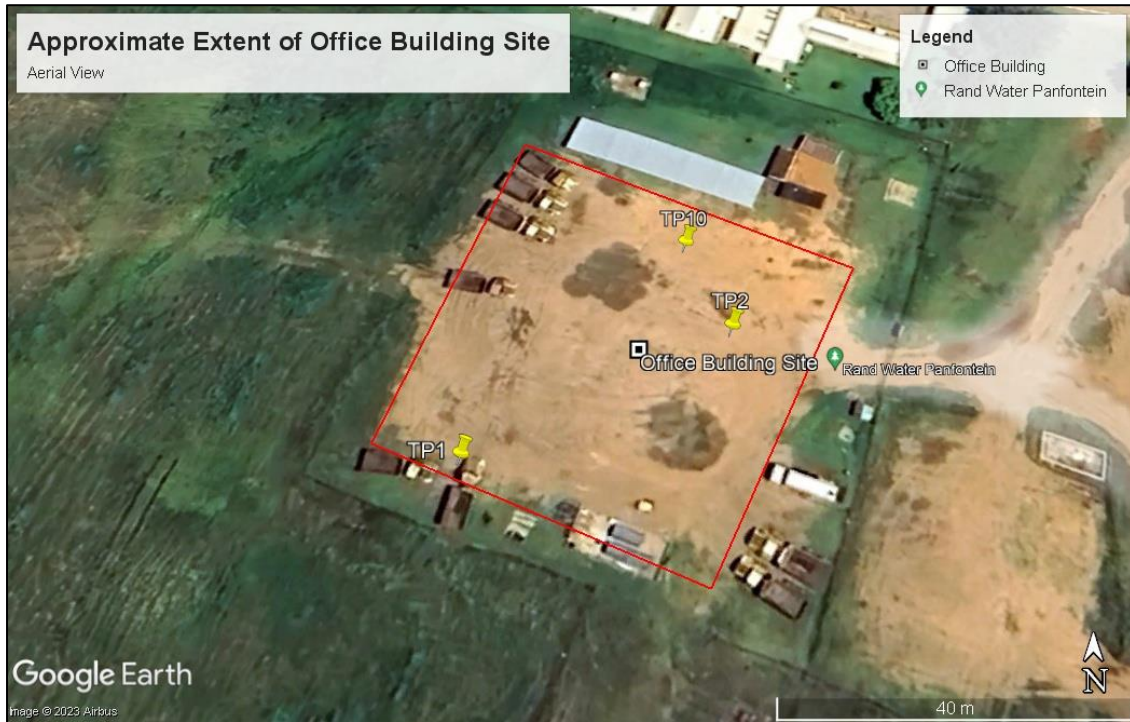
Figure 5: Aerial view of the Office Building site extracted from Google Earth

The Office Building site is situated on the south-western side from the current administration buildings. The site is an open space with to a currently utilised septic tank situated towards the north-western corner of the open space. **Figure 5 below** shows aerial view of the site, extracted from Google Earth images.

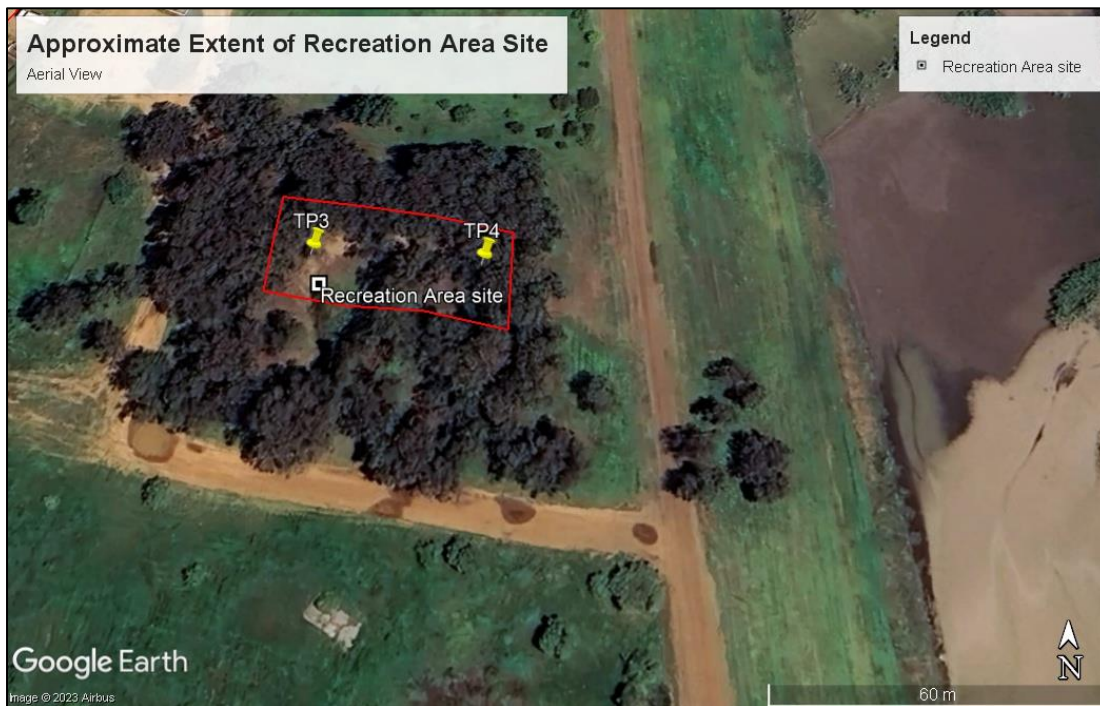
Figure 6: Aerial view of recreational area site extracted from Google Earth

This area will be constructed at an area with a significant tree density. At the time of the field work, there was a thatched roof structure within the site. **Figure 6 below** shows aerial view of the recreational area extracted from Google Earth images.

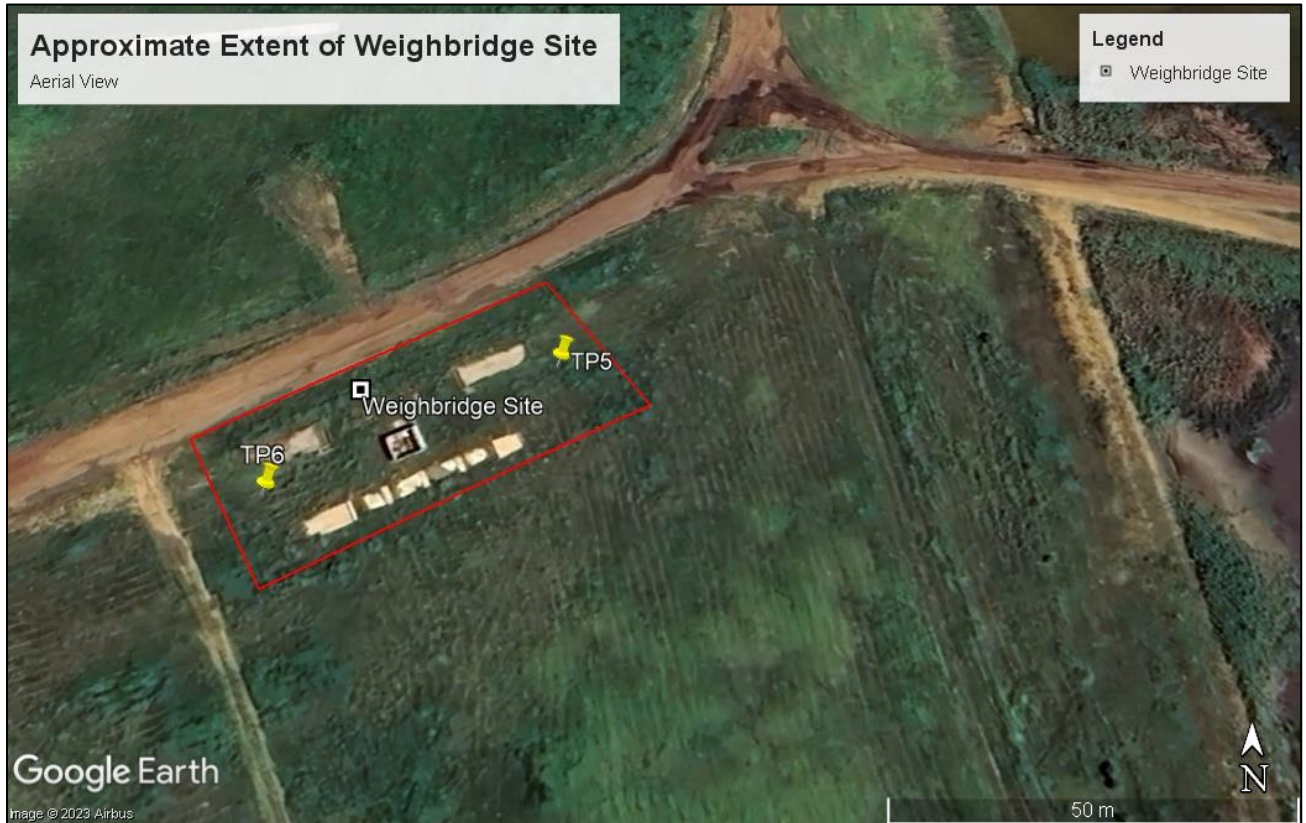
Figure 7: Aerial view of the weighbridge site extracted from Google Earth

The existing weighbridge is dilapidated and what is left are ramps and ruins of a single-story building nearby. The site is adjacent to internal gravel road that heads towards Guardhouse 2. **Figure 7 below** shows an image of the Weighbridge site extracted from Google Earth.

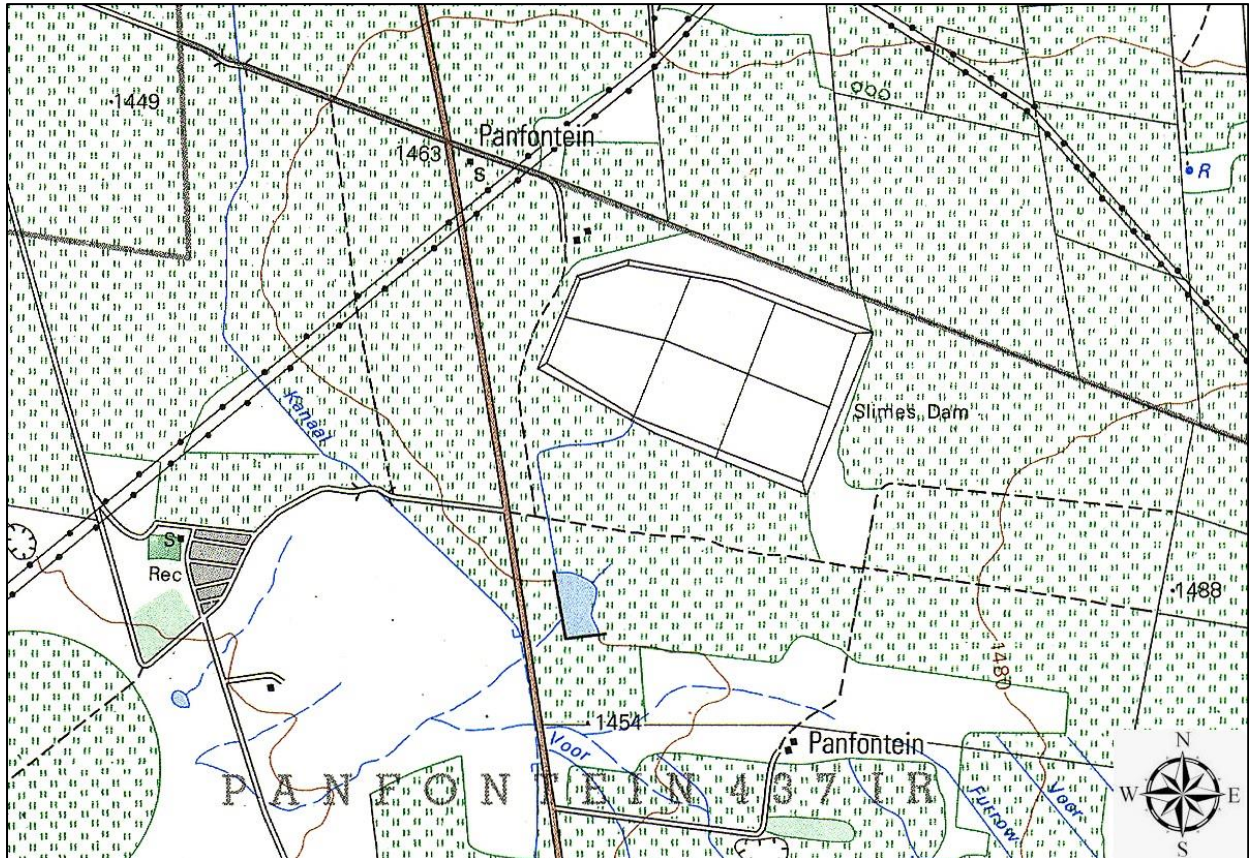
Figure 8 : An extract of topography locality map where Panfontein Rand Water is situated

The sites are situated on a gently sloping terrain towards either north-western or south western direction. **Figure 8 below** shows a scaled topography locality map for the facility extracted from 2628CA Meyerton. The widely spread contour lines illustrate the gentleness of the terrain.

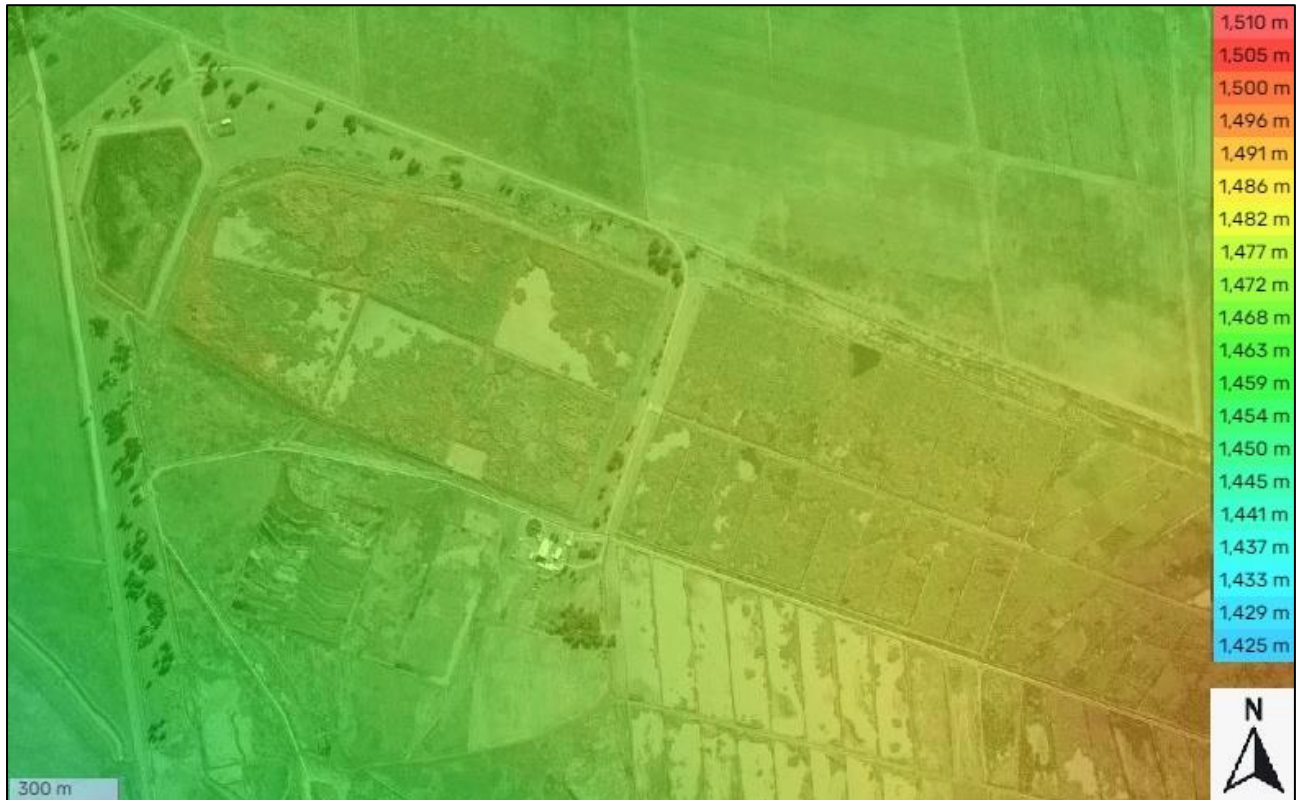
Figure 9 : Different elevation levels displayed at and around the Panfontein Rand Water facility

In addition, **Figure 9 below** shows elevation levels of the areas at and around the Panfontein Rand Water facility. From the figure below, it can be seen that the maximum elevation of the site is about 1,477m asl and the minimum elevation is about 1,463m asl towards the south-western and north western sides.

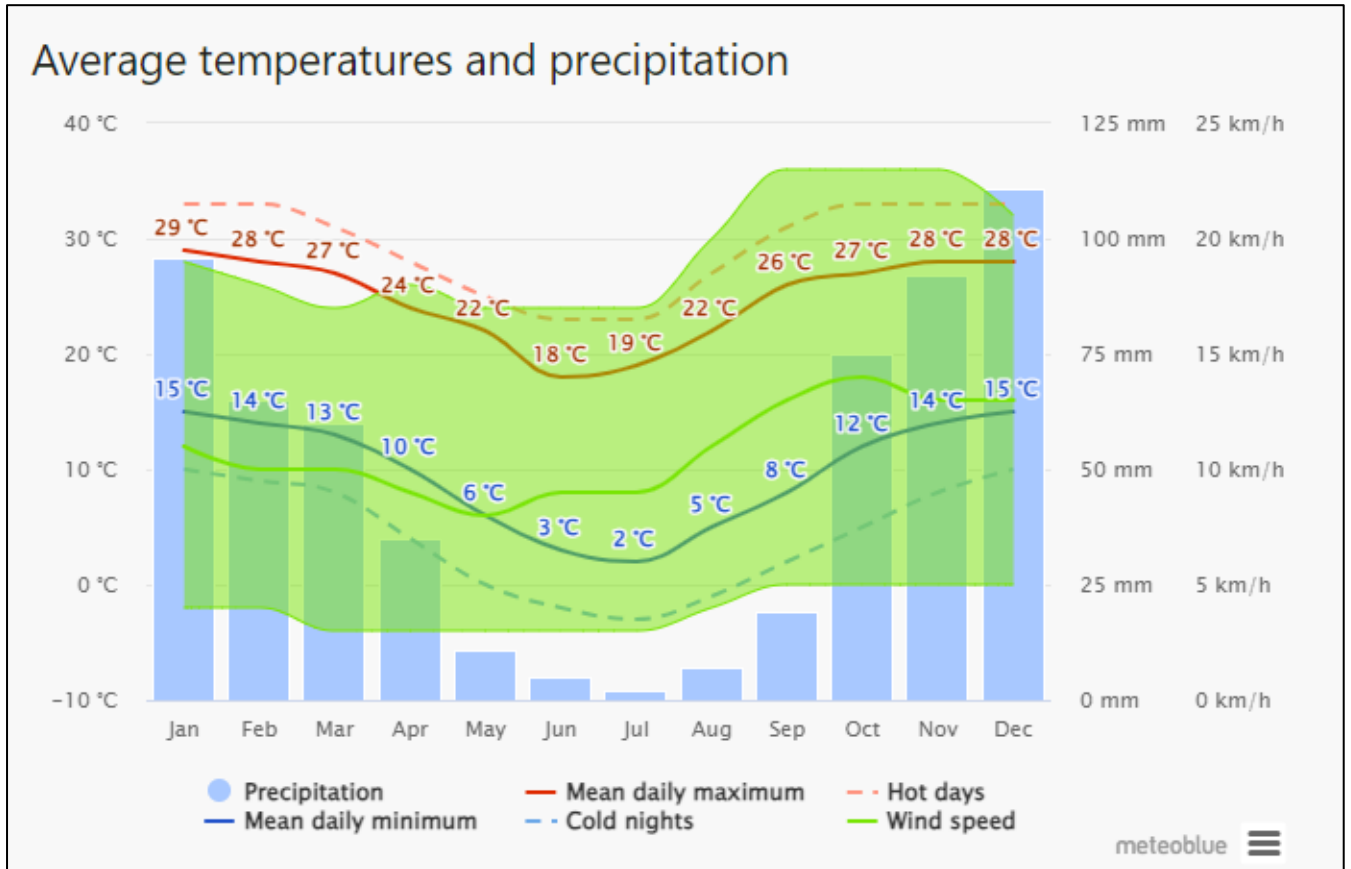
Figure 10: Various graphs illustrating average temperatures, rainfall and wind speeds at Panfontein Rand Water

Simulated historical climate and weather data report compiled by Meteoblue, indicate that this area receives the minimal rainfall (2mm) in July and the highest (111mm) in December. It is reported that, the average daily maximum temperatures at Panfontein Rand Water ranges between 18°C in June and 29°C in January. This area is coldest during the month of July whereby a minimum temperature of -3°C on average during the night may be experienced. The highest wind speed of about 23km/h may be anticipated between the months of September and November. **Figure 10 below** shows graphs of average temperatures, wind speed and rainfall at facility.

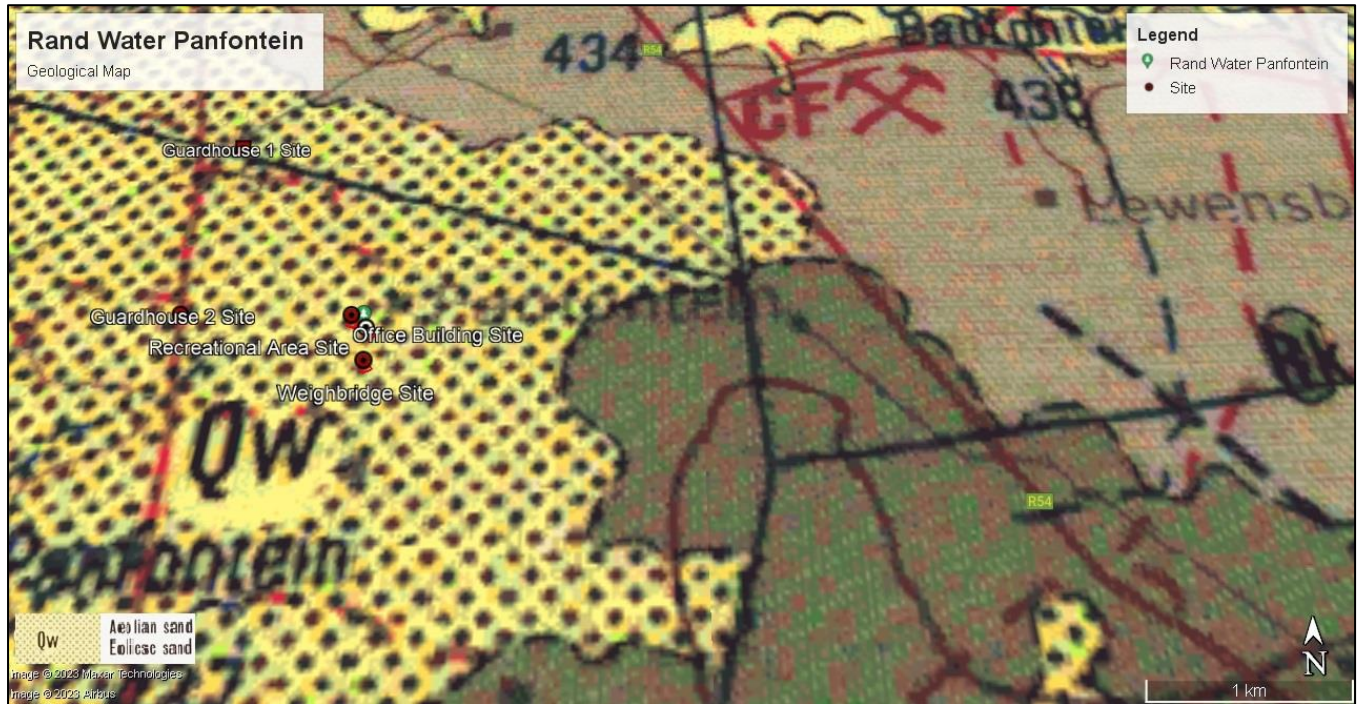
Figure 11: Regional geology of the area where the sites are situated extracted from 2628 East Rand Geological Map

The Geological Map Series, sheet number 2628 East Rand, published at a scale of 1:250 000 by Council for Geosciences indicate that the sites are situated on the area that is covered with a mantle of aeolian sand of which, at some places, is underlain by basalt rock of Kliprievsberg Group under Ventersdorp Supergroup. **Figure 11 below** shows a scaled geological map of the area where the sites are situated extracted from 2628 East Rand Geological Map and generated using Google Earth.

The geological map shown on **Figure 11 above** illustrate that there is no dolomite where the sites are situated. It is therefore not expected that the sites can be prone to dolines and/or sinkholes formation.

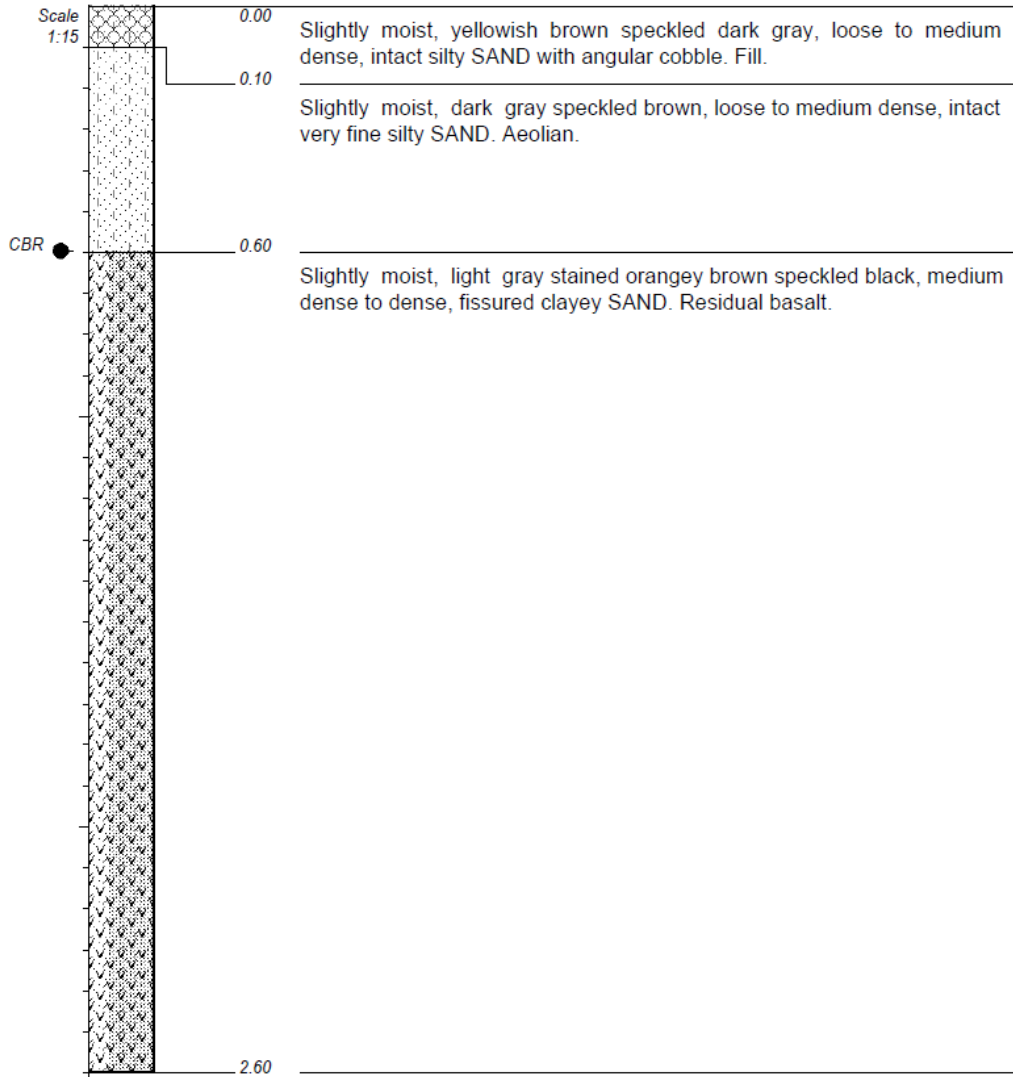
HOLE No: TP2
Sheet 1 of 1

- 1) End of hole
- 2) No groundwater seepage
- 3) No side wall collapse
- 4) Disturbed sample of Mod CBR, Foundation Indicator, pH, EC, Single Oedometer, Collapse Potential between 0.6 -2.60m

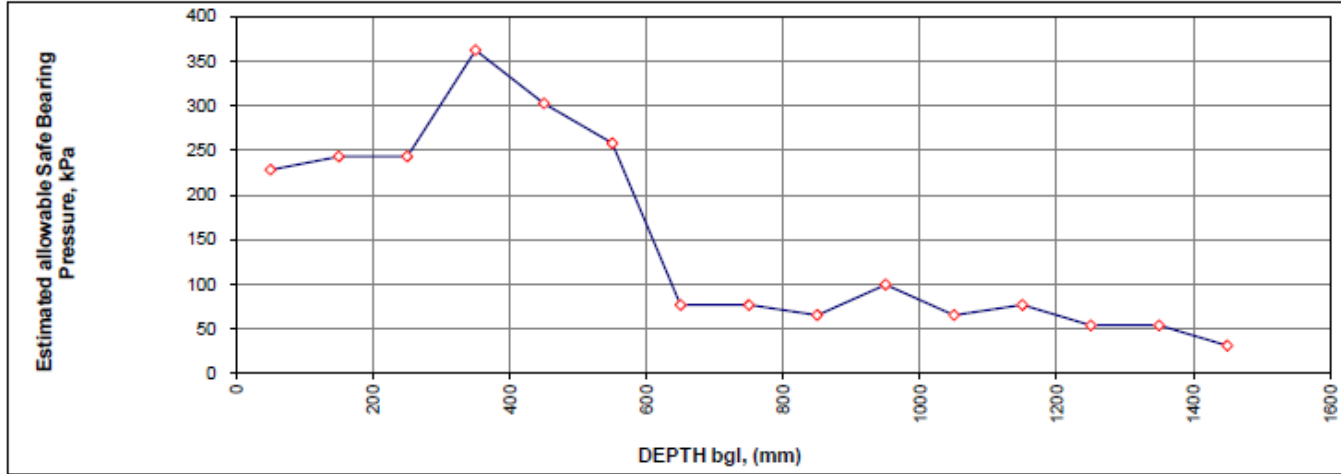
note: EASBP from Terzaghi & Peck p491 for 25mm settlement

Dynamic Cone Penetration can assist in determining the estimated allowable safe bearing pressures (EASBP) of the soils. **Appendix B** shows that the EASBP values range between as high as 240kPa but decrease to as low as between 54kPa and 31kPa at 1.5m depth. It was only at a Recreational Area site whereby the EASBP increased on a very dense clayey sand to 600kPa at 1.0m below ground level. The decrease in EASBP will require a foundation that will accommodate weak areas that have low EASBP values. The high consistency of the clayey sand at the **Recreational Area site** may be mostly influenced by a relatively dry conditions compared to other sites. Introduction of the moisture content on the clayey sand may similarly reduce the EASBP to levels that were observed at other four sites.

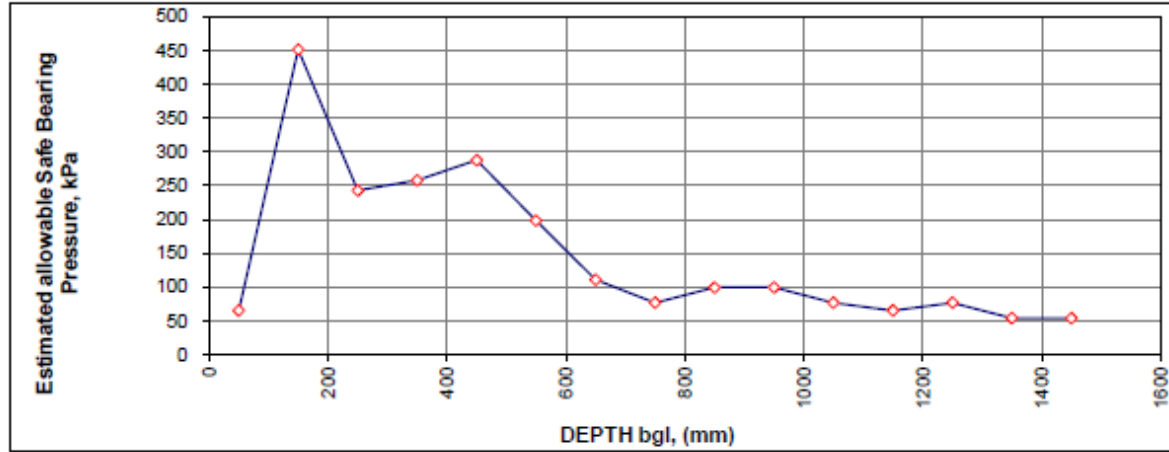
note: EASBP from Terzaghi & Peck p491 for 25mm settlement

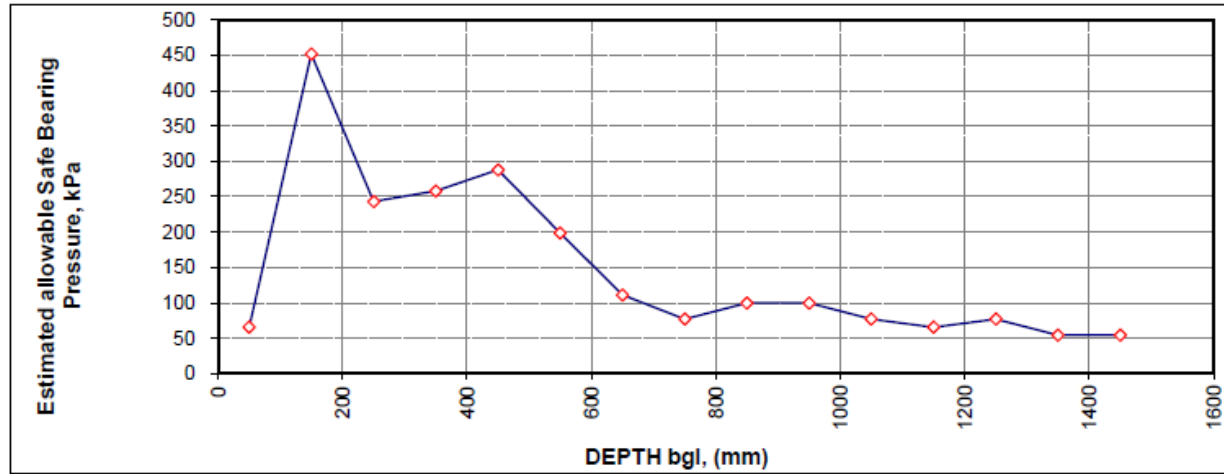
note: EASBP from Terzaghi & Peck p491 for 25mm settlement

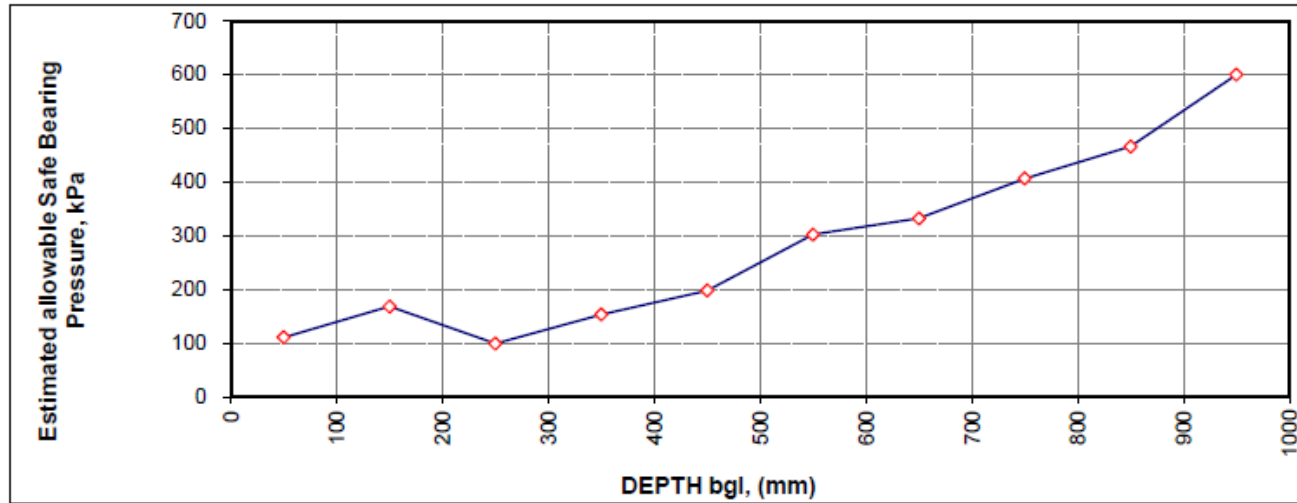
note: EASBP from Terzaghi & Peck p491 for 25mm settlement

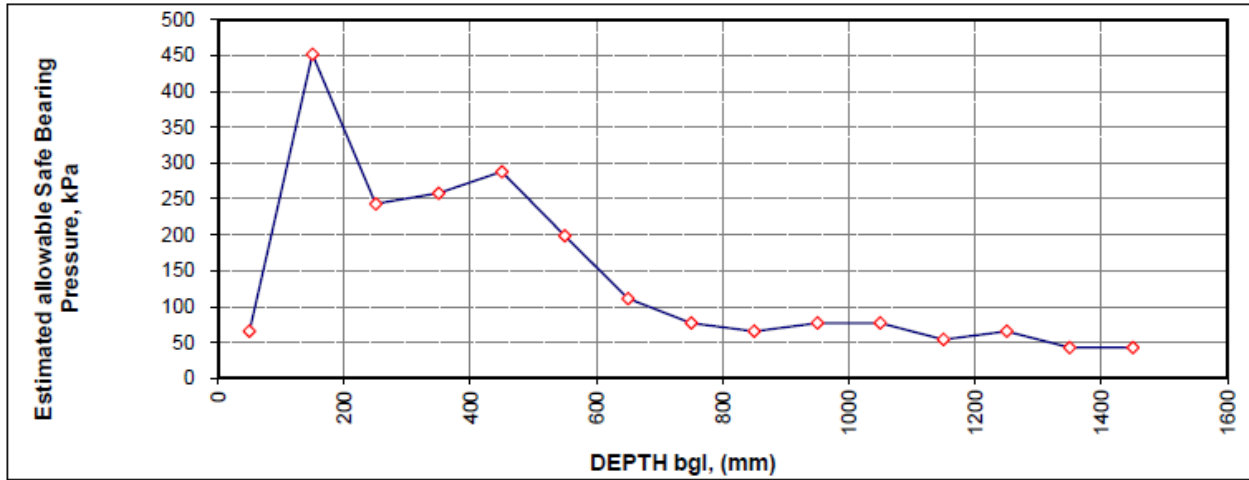
note: EASBP from Terzaghi & Peck p491 for 25mm settlement

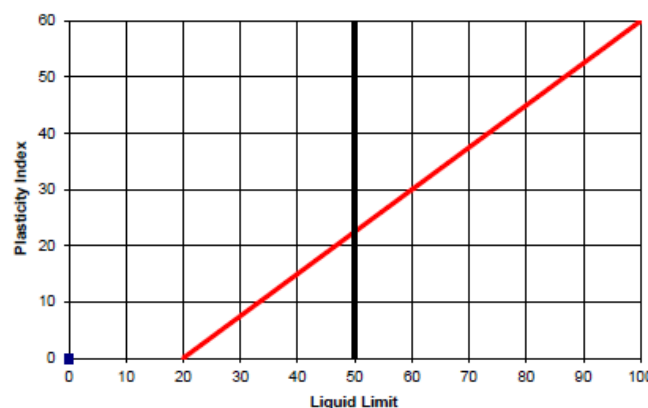
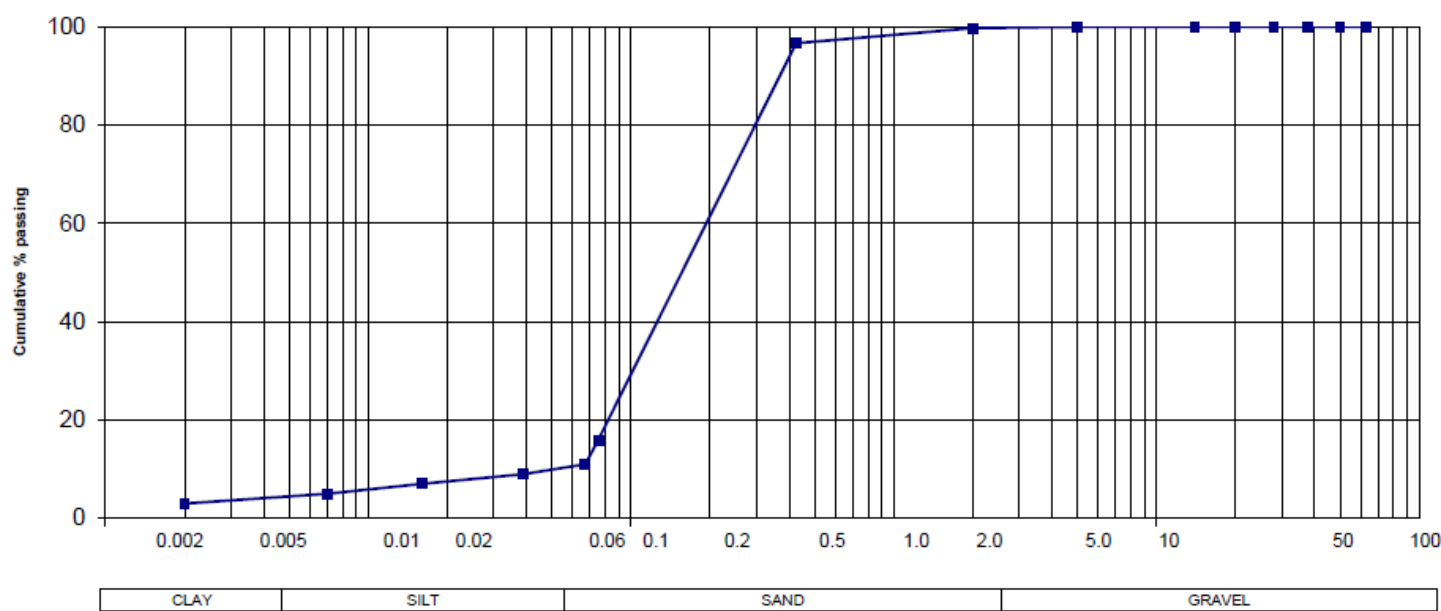
PLASTICITY CHART

Sample No.	02
Soillab Sample No.	S23-0353-02
Depth (mM)	0.0 - 0.9
Position	TP03
Material Description	LIGHT GREY SILTY SAND
Relative density on < 2 mm (TMH1 A12T)	2.585
Organic Material	
Moisture (%)	
SCREEN ANALYSIS (% PASSING) (SANS 3001:GR1)	
63.0 mm	100
50.0 mm	100
37.5 mm	100
28.0 mm	100
20.0 mm	100
14.0 mm	100
5.0 mm	100
2.00 mm	100
0.425 mm	97
0.075 mm	16
HYDROMETER ANALYSIS (% PASSING) (SANS 3001:GR3)	
67 µm	11
39 µm	9
16 µm	7
7 µm	5
2 µm	3
% Clay	5
% Silt	6
% Sand	89
% Gravel	0
ATTERBERG LIMITS (SANS 3001:GR10)	
Liquid Limit	
Plasticity Index	NP
Linear Shrinkage (%)	0.0
Grading Modulus	0.88
Classification	A-2-4 (0)
Unified Classification	SM
Chart Reference

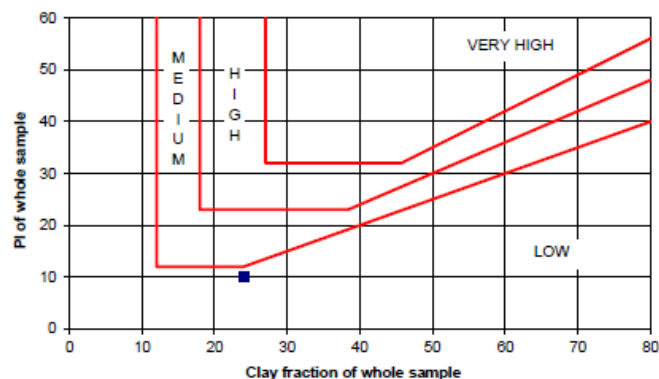
POTENTIAL EXPANSIVENESS

Sample No.	03
Soillab Sample No.	S23-0353-03
Depth (mM)	0.8 - 2.8
Position	TP05
Material Description	DARK YELLOW CLAYEY SAND
Relative density on < 2 mm (TMH1 A12T)	2.634
Organic Material	
Moisture (%)	
SCREEN ANALYSIS (% PASSING) (SANS 3001:GR1)	
63.0 mm	100
50.0 mm	100
37.5 mm	100
28.0 mm	100
20.0 mm	100
14.0 mm	97
5.0 mm	88
2.00 mm	85
0.425 mm	83
0.075 mm	34
HYDROMETER ANALYSIS (% PASSING) (SANS 3001:GR3)	
62 µm	31
36 µm	29
14 µm	26
6 µm	24
2 µm	23
% Clay	24
% Silt	7
% Sand	54
% Gravel	15
ATTERBERG LIMITS (SANS 3001:GR10)	
Liquid Limit	32
Plasticity Index	12
Linear Shrinkage (%)	4.0
Grading Modulus	0.98
Classification	A-2-6 (0)
Unified Classification	SC
Chart Reference

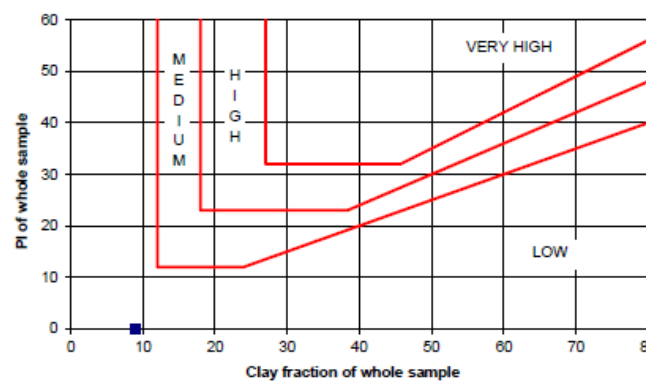
POTENTIAL EXPANSIVENESS

Sample No.	04
Soillab Sample No.	S23-0353-04
Depth (mM)	0.0 - 1.10
Position	TP07
Material Description	DARK BROWN SILTY SAND
Relative density on < 2 mm (TMH1 A12T)	2.621
Organic Material	
Moisture (%)	
SCREEN ANALYSIS (% PASSING) (SANS 3001:GR1)	
63.0 mm	100
50.0 mm	100
37.5 mm	100
28.0 mm	100
20.0 mm	100
14.0 mm	98
5.0 mm	95
2.00 mm	95
0.425 mm	93
0.075 mm	23
HYDROMETER ANALYSIS (% PASSING) (SANS 3001:GR3)	
65 µm	20
38 µm	16
15 µm	11
7 µm	9
2 µm	7
% Clay	9
% Silt	11
% Sand	75
% Gravel	5
ATTERBERG LIMITS (SANS 3001:GR10)	
Liquid Limit	
Plasticity Index	NP
Linear Shrinkage (%)	0.0
Grading Modulus	0.89
Classification	A-2-4 (0)
Unified Classification	SM
Chart Reference

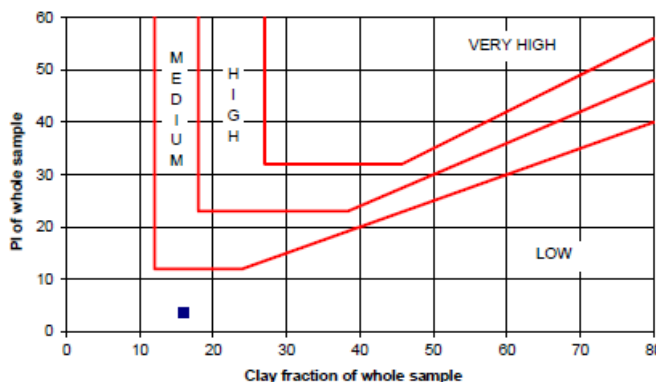
POTENTIAL EXPANSIVENESS

Sample No.	05
Soillab Sample No.	S23-0353-05
Depth (mM)	0.8 - 2.70
Position	TP09
Material Description	DARK YELLOW GRAVELLY SAND
Relative density on < 2 mm (TMH1 A12T)	2.638
Organic Material	
Moisture (%)	
SCREEN ANALYSIS (% PASSING) (SANS 3001:GR1)	
63.0 mm	100
50.0 mm	100
37.5 mm	100
28.0 mm	100
20.0 mm	100
14.0 mm	96
5.0 mm	74
2.00 mm	67
0.425 mm	63
0.075 mm	30
HYDROMETER ANALYSIS (% PASSING) (SANS 3001:GR3)	
62 µm	23
36 µm	21
15 µm	17
6 µm	16
2 µm	15
% Clay	16
% Silt	7
% Sand	44
% Gravel	33
ATTERBERG LIMITS (SANS 3001:GR10)	
Liquid Limit	25
Plasticity Index	6
Linear Shrinkage (%)	3.0
Grading Modulus	1.40
Classification	A-2-4 (0)
Unified Classification	SM & SC
Chart Reference

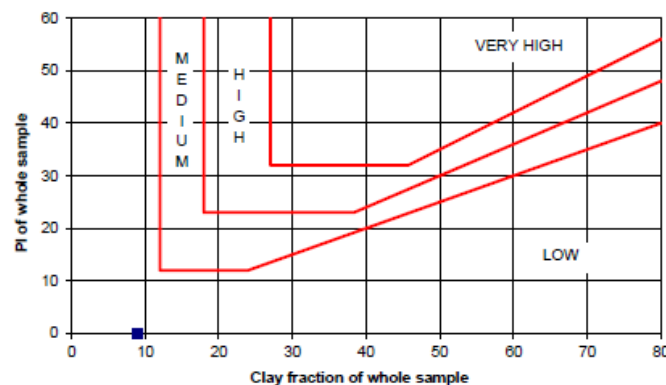
POTENTIAL EXPANSIVENESS

Sample No.	06
Soillab Sample No.	S23-0353-06
Depth (mM)	0.0 - 1.20
Position	TP 10
Material Description	DARK BROWN SILTY SAND
Relative density on < 2 mm (TMH1 A12T)	2.637
Organic Material	
Moisture (%)	
SCREEN ANALYSIS (% PASSING) (SANS 3001:GR1)	
63.0 mm	100
50.0 mm	100
37.5 mm	100
28.0 mm	100
20.0 mm	100
14.0 mm	100
5.0 mm	99
2.00 mm	99
0.425 mm	96
0.075 mm	23
HYDROMETER ANALYSIS (% PASSING) (SANS 3001:GR3)	
66 µm	19
38 µm	15
15 µm	11
7 µm	9
2 µm	7
% Clay	9
% Silt	10
% Sand	80
% Gravel	1
ATTERBERG LIMITS (SANS 3001:GR10)	
Liquid Limit	
Plasticity Index	NP
Linear Shrinkage (%)	0.0
Grading Modulus	0.82
Classification	A-2-4 (0)
Unified Classification	SM
Chart Reference

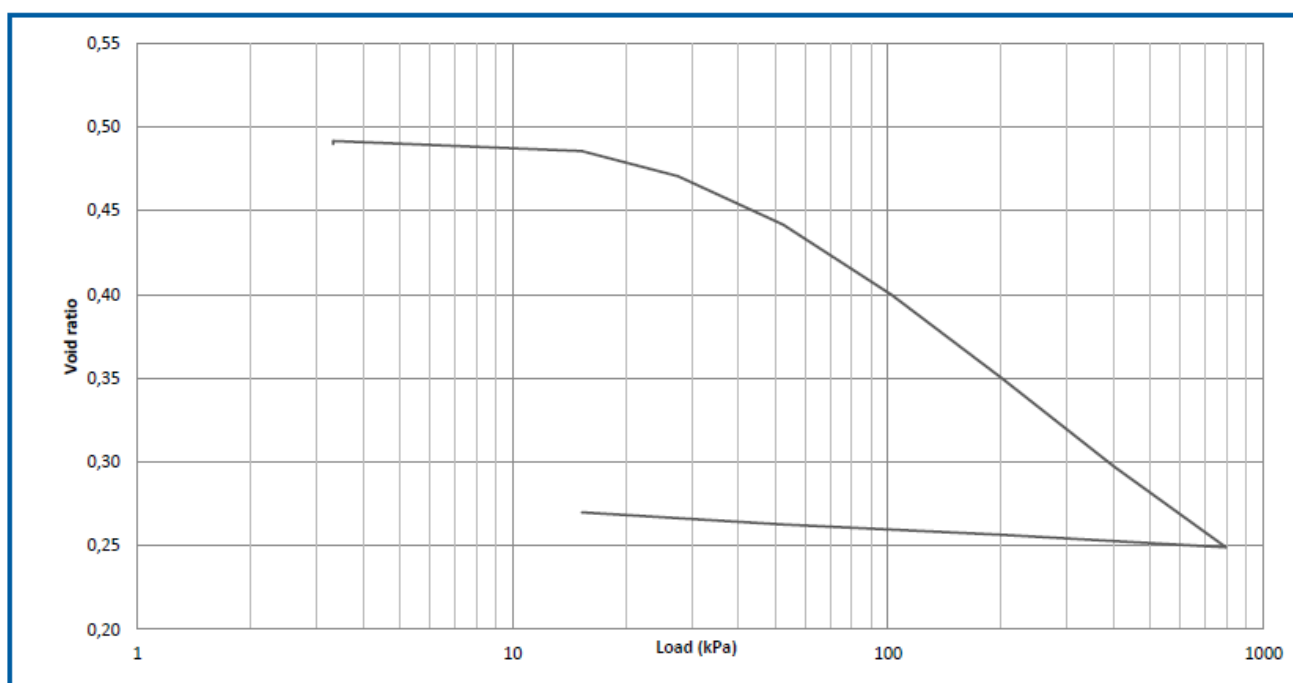
Initial	Final	
Sample Height:	19,38	16,52	mm
Sample Mass:	115,38	115,60	g
Dry Density:	1756	2060	kg/m ³
Density:	1977	2324	kg/m ³
Moisture Content:	12,6	12,8	%
Void Ratio:	0,490	0,270	
Specific Gravity:	2,616		Mg/m ³

* - m_v values provided are incremental and only valid for the specific load increment.

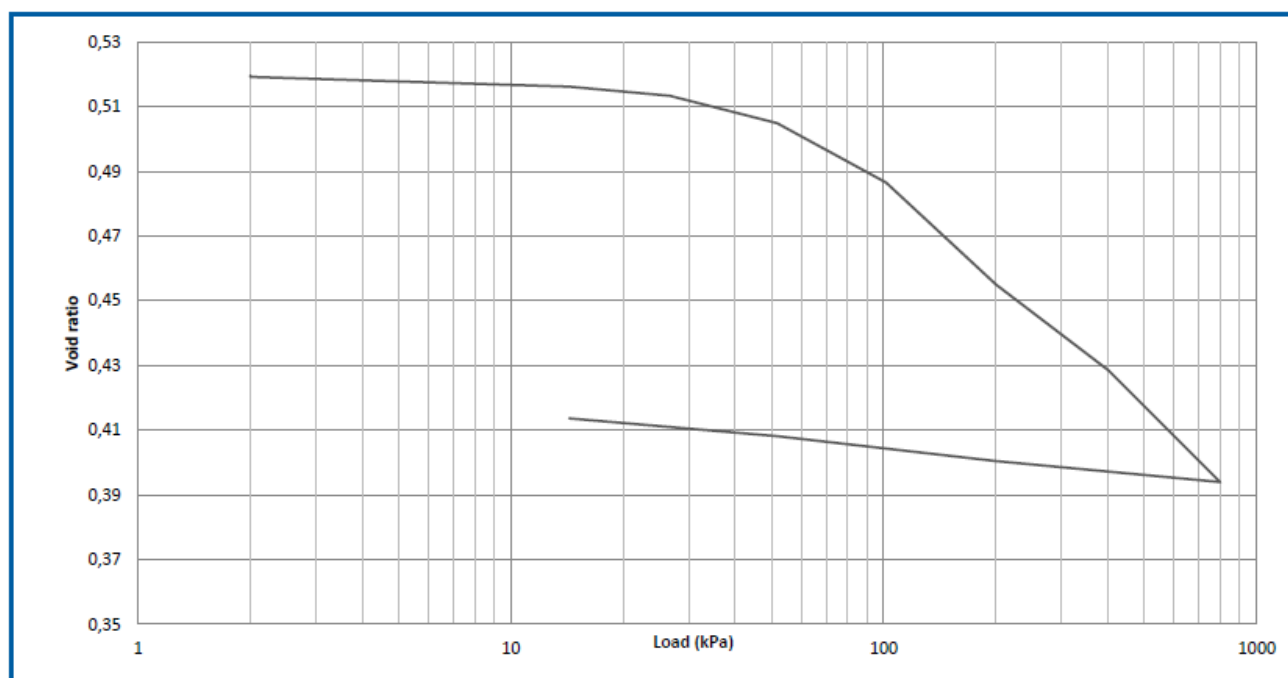
Initial	Final	
Sample Height:	19,62	18,25	mm
Sample Mass:	116,04	119,07	g
Dry Density:	1724	1853	kg/m ³
Density:	1974	2177	kg/m ³
Moisture Content:	14,5	17,5	%
Void Ratio:	0,520	0,414	
Specific Gravity:	2,619		Mg/m ³

* - m_v values provided are incremental and only valid for the specific load increment.

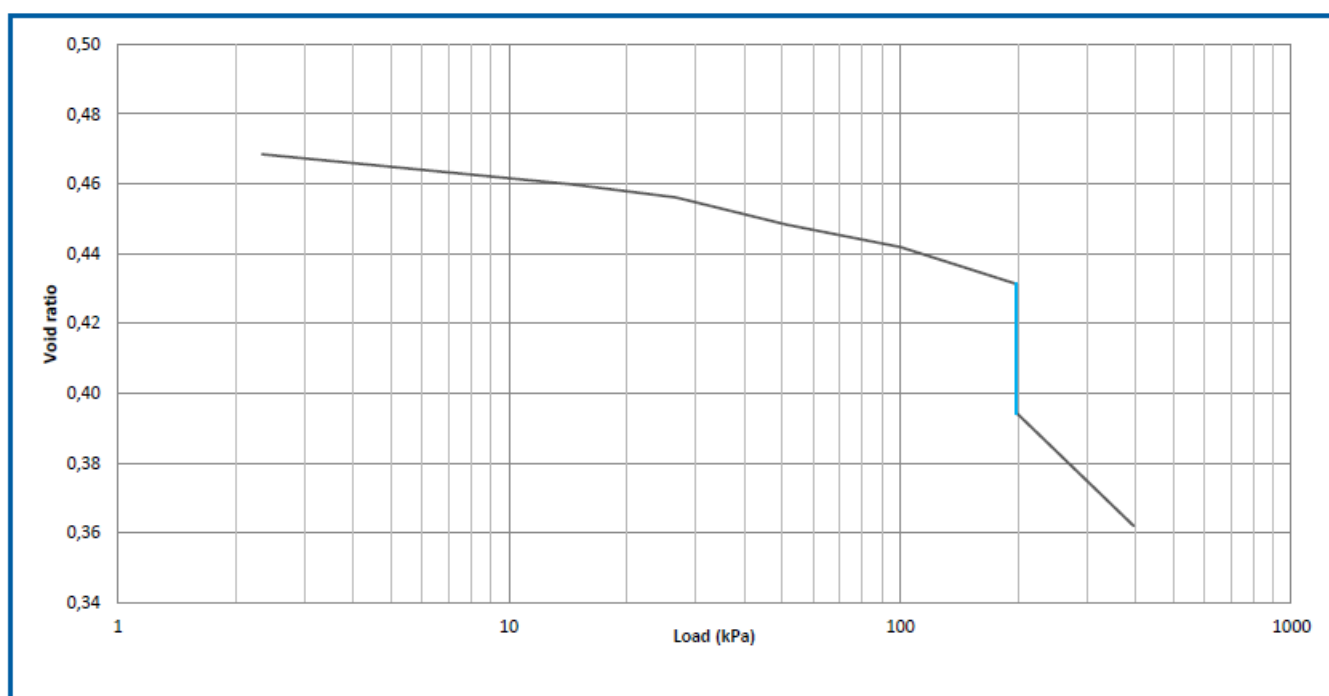
Load kPa	Height mm	Void Ratio
2,3	19,52	0,468
14,4	19,406	0,460
26,7	19,356	0,456
51,1	19,252	0,448
100,3	19,166	0,442
198,5	19,026	0,431
198,5	18,534	0,394
395,4	18,104	0,362

Initial	Final	
Sample Height:	19,52	18,10	mm
Sample Mass:	117,1	119,8	g
Dry Density:	1781	1921	kg/m ³
Density:	2006	2211	kg/m ³
Moisture Content:	12,6	15,1	%
Void Ratio:	0,468	0,362	
Specific Gravity:	2,616		Mg/m ³
