SPECIALIST DECLARATION FORM – AUGUST 2023

Geotechnical Assessment Study for Panfontein _Rand Water

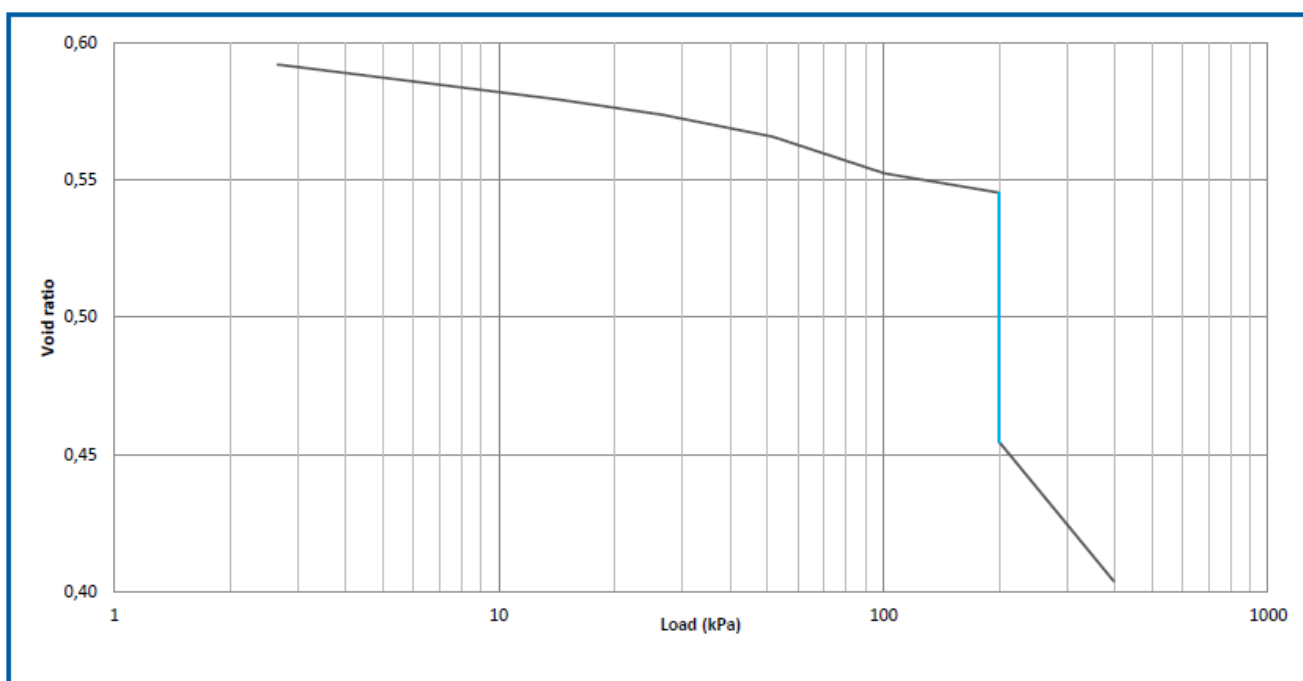
Load kPa	Height mm	Void Ratio
2,7	20	0,592
14,3	19,84	0,579
26,6	19,77	0,574
51,5	19,67	0,566
100,7	19,502	0,552
199,8	19,413	0,545
199,8	18,273	0,455
397,2	17,634	0,404

Initial	Final	
Sample Height:	20,00	17,63	mm
Sample Mass:	113,3	115,7	g
Dry Density:	1645	1866	kg/m ³
Density:	1884	2181	kg/m ³
Moisture Content:	14,5	16,9	%
Void Ratio:	0,592	0,404	
Specific Gravity:	2,619		Mg/m ³
